PROPERTY INSPECTION REPORT

By: Fred Willcox TREC License No. 160 2008

STRUCTURAL INSPECTION

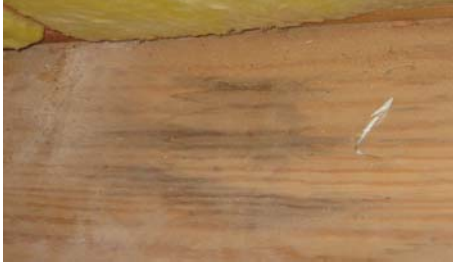
Water stains, indicating the possibility of active roof leaks, were found on the floor of the attic, etc. The source(s) of the water stains should be determined and repaired.

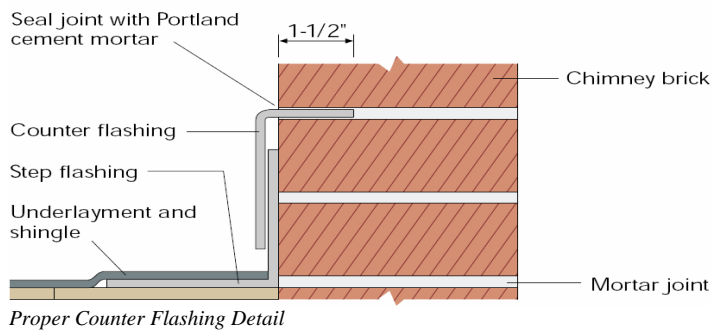
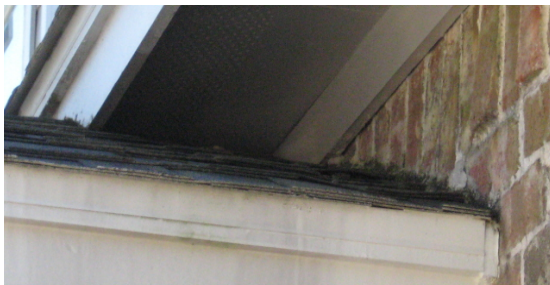
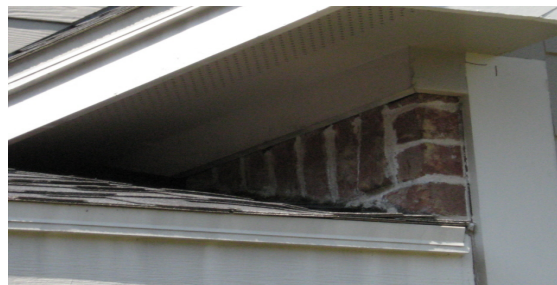
COUNTER FLASHING DETAILS

There was no visible step flashing or counter flashing installed at the junctions of the roof deck with the siding at the breeze/brick junction at the house and garage. Step flashing is required to seal the junctions between the shingles and the walls. The purpose of counter flashing is to seal the opening between the tops of the step flashing sections and the brick veneer. The tab on the counter flashing is supposed to be cut back into the brick veneer to create a positive seal that covers the gap between the top of the flashing and the side of the brick. Flashing and counter flashing must be installed for the roof covering material to perform properly.

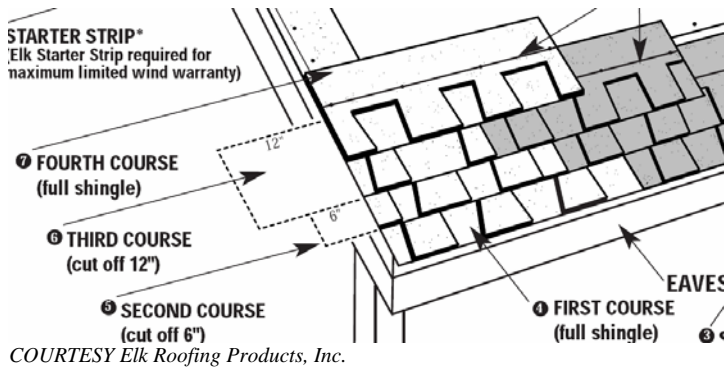
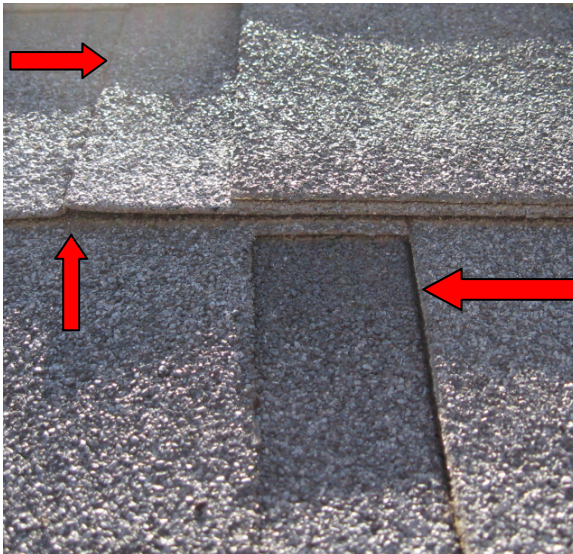
Some of the shingles were improperly spaced. There was an inadequate gap between some of the shingles which caused the edges of the shingles to overlap. The raised edge of the side of the shingle creates an area where high winds can catch the shingles and strip them from the roof deck. The roofing shingles should be removed and new, properly spaced shingles should be installed.

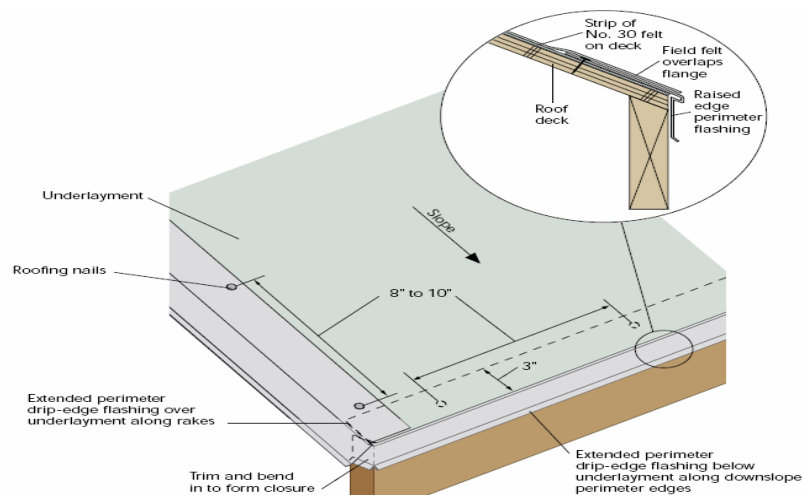
The roofing felt did not extend to the rakes or bottom of the roof deck in all of the areas that were inspected. This is an improper installation as the roof decking material may be exposed to water. The roofing felt should be extended all the way to the edge of the rakes and bottom of the roof decking material and the felt should be properly terminated on top of the drip edge flashing at the drip edges of the roof. The edge flashing should be installed on top of the roofing felt at the rakes to help prevent the felt from being stripped from the roof deck in high winds.

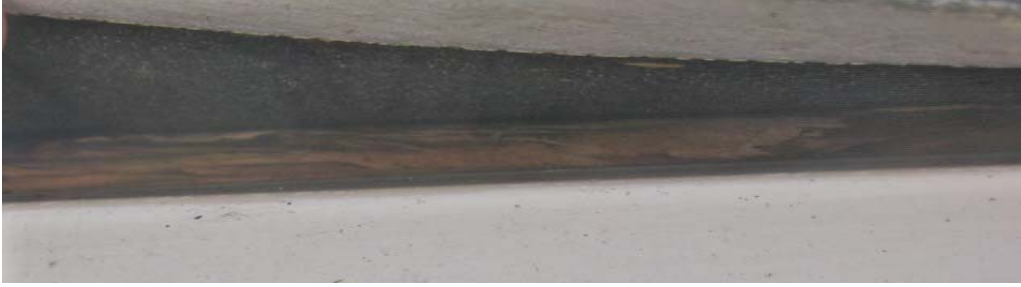
Some of the roofing shingles were improperly fastened to the roof deck. All shingles are required to have a minimum of four fasteners per shingle, six fasteners in high wind zones. The fasteners are required to be located in the nailing strip so that the fastener penetrates the shingle in approximately the middle of the shingle and penetrates the underlying shingle along the top of that shingle. Fasteners are required to be located close to the rakes and ends of each shingle to reduce the chances of the shingle from being stripped in high winds. All shingles should be properly and correctly fastened to the roof deck to prevent the shingles from being stripped from the roof in high wind conditions.

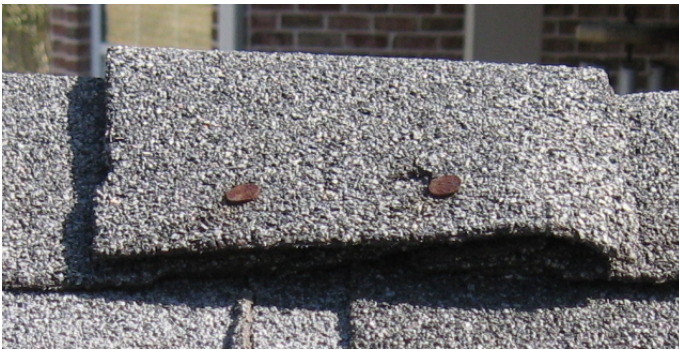
Exposed fasteners were noted in several areas of the roof's surface. The heads of the nails will rust and deteriorate, leaving openings through the roof covering material. The exposed fasteners should be covered and sealed.

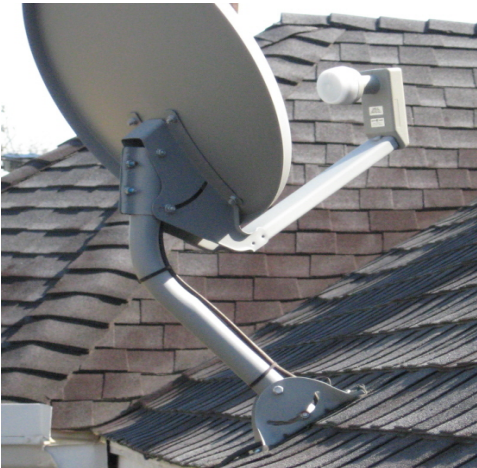
The dish for the satellite antenna system had been bolted to the roof deck through the shingles. There was no attempted to make the junction of the bracket with the shingles or the penetrations of the bolts through the shingles water proof. The bracket junction and the bolt penetrations should be made water proof or the dish should be removed from the surface of the roof. If the dish is removed, the damaged shingles should be replaced.

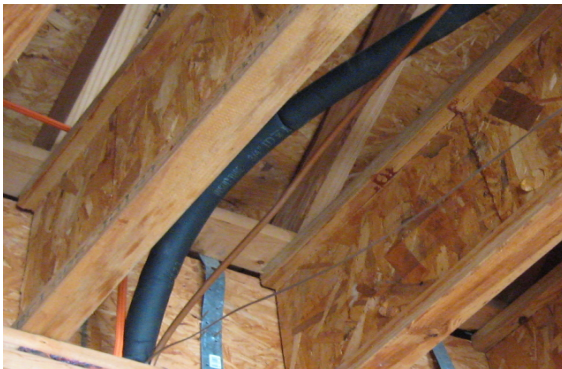
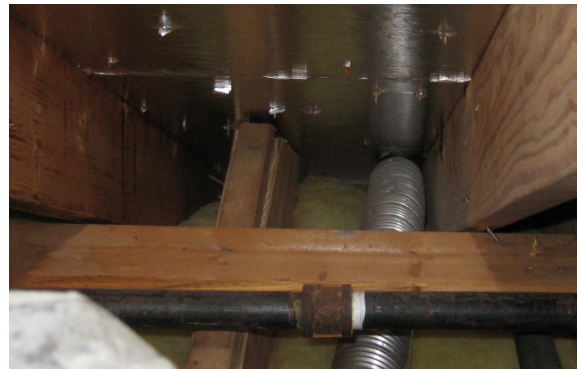
The ends of the rafters and joists were not nailed together at the double plate in the house and garage. The ends of the joists and rafters are required to be nailed together to provide continuity to the framing as required by Section 802.3.1 of the IRC. The joists and rafters ends should be properly fastened together to provide continuity to the framing.

802.3.1 Ceiling joist and rafter connections.

Ceiling joists and rafters shall be nailed to each other in accordance with Tables R602.3(1) and R802.5.1(9), and the assembly shall be nailed to the top wall plate in accordance with Table R602.3(1). Ceiling joists shall be continuous or securely joined where they meet over interior partitions and nailed to adjacent rafters to provide a continuous tie across the building when such joists are parallel to the rafters.

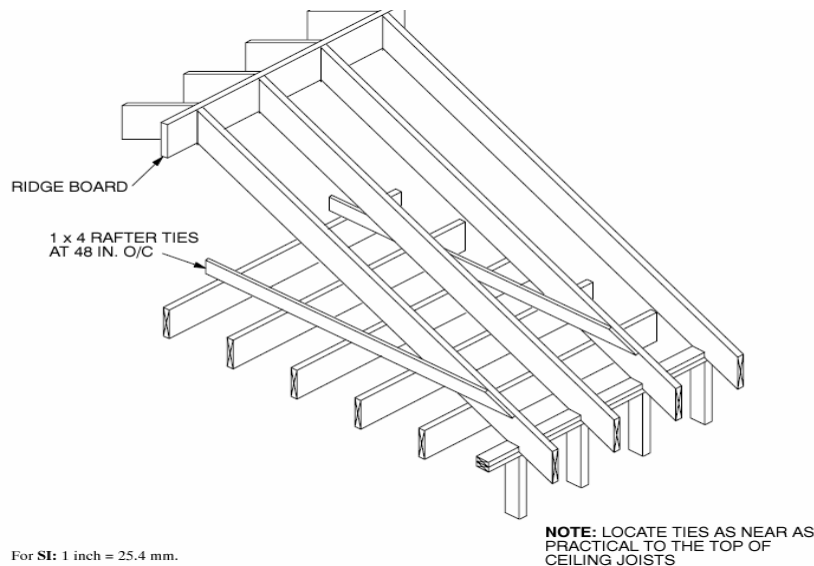
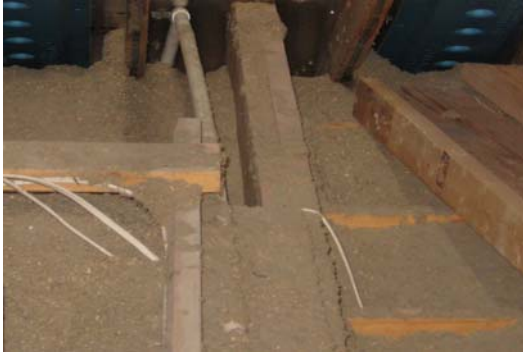
Rafter ties were improperly installed or were not present in the attic of the structure. Rafter ties are used to prevent the exterior walls parallel to the joists from spreading from the loads imposed by the hip roof when the joists are not installed parallel to the rafters. The rafter ties, in this case, were strong backs. The strong backs were not connected to the ends of the rafters or to the top of the exterior wall. There were gaps in the

strong backs which reduce the strength of the strong backs. There were also an inadequate number of rafter ties installed per Section R802.3.1 of the IRC.

Where ceiling joists are not parallel to rafters, subflooring or metal straps attached to the ends of the rafters shall be installed in a manner to provide a continuous tie across the building, or rafters shall be tied to 1-inch by 4-inch (25.4 mm by 102 mm) (nominal) minimum-size cross ties. The connections shall be in accordance with Table R602.3(1) or connections of equivalent capacities shall be provided. Where ceiling joists or rafter ties are not provided at the top plate, the ridge formed by these rafters shall also be supported by a girder designed in accordance with accepted engineering practice.

Rafter ties shall be spaced not more than 4 feet (1219 mm) on center.

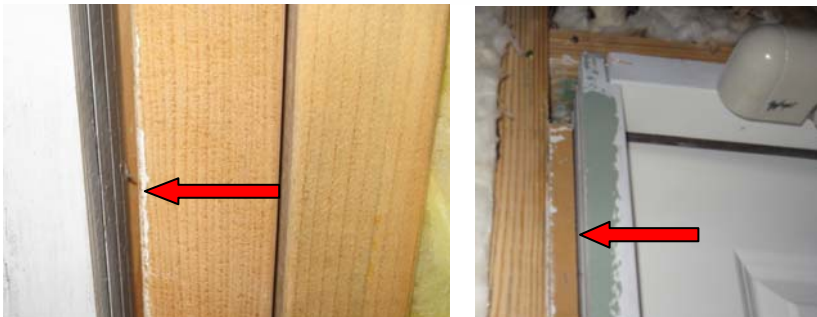
The inspection of the wall corners, framing penetrations, attic access ladder and door frames in the accessible attic areas revealed that all of the junctions and penetrations were not sealed in accordance with the International Energy Code, Section 502.1.4.2 and Section N1102.1.10 of the International Residential Code, as required by the State of Texas. It is important that all areas, including those that are not visible or accessible, be properly sealed as your air conditioning system has been designed with the idea that the house has been properly sealed. If the house is not properly insulated and sealed, your air conditioning system may not function properly.

N1102.1.10 Air leakage.

All joints, seams, penetrations; site-built windows, doors, and skylights; openings between window and door assemblies and their respective jambs and framing; and other sources of air leakage (infiltration and exfiltration) through the building thermal envelope shall be caulked, gasketed, weather-stripped, wrapped, or otherwise sealed to limit uncontrolled air movement.

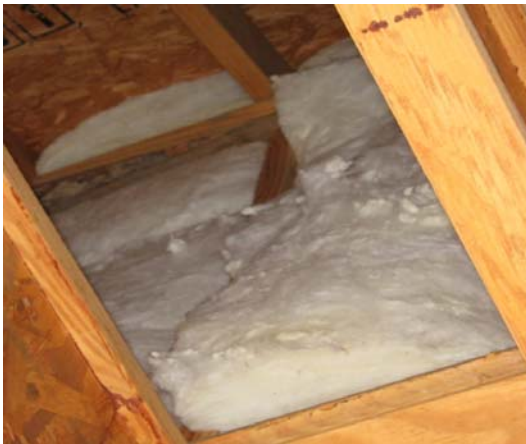
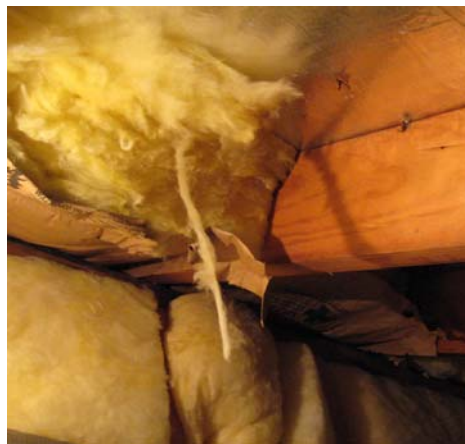
Although levels of insulation varied from zero to 10 inches throughout the attic space, the average depth of insulation appeared to be eight inches. Inadequately or uninsulated areas of the attic fronting air conditioned surfaces should be insulated.

The attic areas were inadequately ventilated in my opinion. Additional ventilation should be installed.

Insulation was installed in the air chases between the vaulted ceilings and the roof. The installation of the insulation in these areas reduces or eliminates air flow from the soffit vents into the attic spaces. It was noted that the attic areas were very warm even though it was a cool day. In addition to restricting or eliminating air flow into the attic areas, air spaces between the insulating materials and the surfaces of the roofing material and ceiling material can allow condensation to form. The manufacturers of insulating material require that the material stay in contact with any surface above the insulation materials to prevent air gaps, which can allow the creation of condensation, from forming. The insulating material should be removed from these areas to allow additional air flow into the attic spaces and to reduce the chances of condensation forming and damaging the wooden materials.
