■ □ □ ■ **E. Walls (Interior and Exterior)**

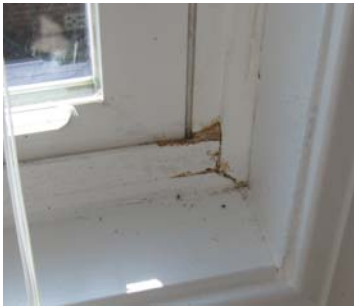
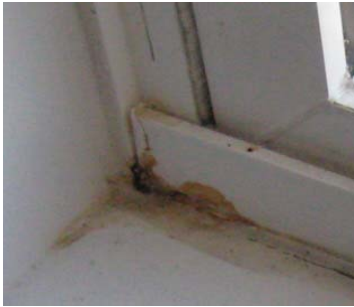
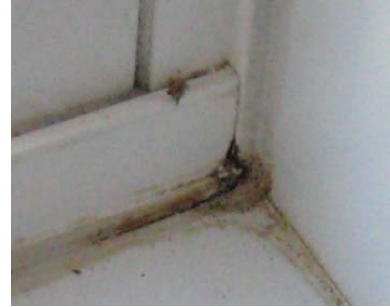
Water penetration was noted on the interior of the walls at the window frames in the house and in the garage apartment. The sources of the water penetration should be determined and repaired. The presence of water penetration may indicate the growth of microbial organic organisms that may be toxic. Indoor air quality tests are not a part of this inspection. Should you desire an indoor air quality test, the test should be arranged prior to closing. Once the sources of the water penetration have been determined and repaired, all decayed, deteriorated or damaged materials, including walls covering materials, trim, moldings, insulation and framing members should be removed and replaced and finished to match the existing structure.

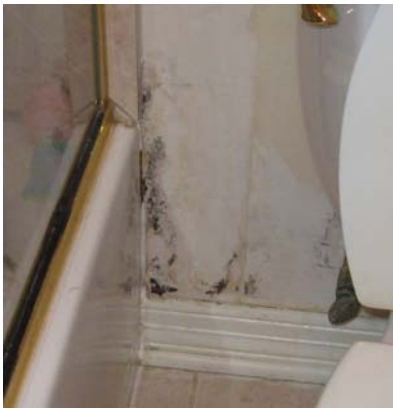
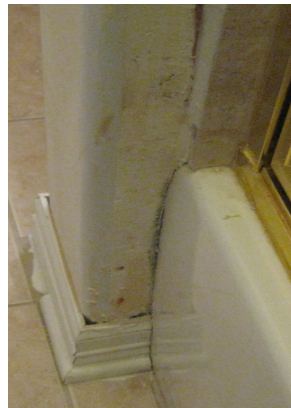
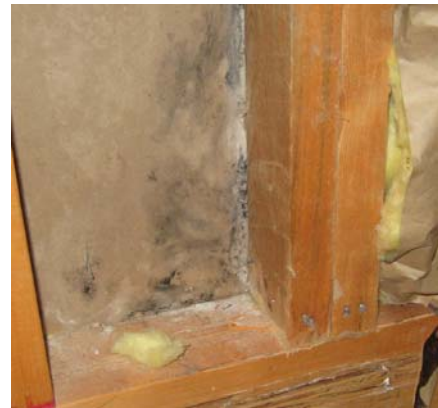
Microbial organic growths were noted on the walls in the upstairs bathroom and in the attic behind the upstairs bathtub, etc. The identity of the microbial organic growths can only be determined by laboratory culturing and testing, which is not a part of a visual real estate inspection. The growths should be identified. The organisms should be treated and killed for safety. The causes of the growths should be determined and corrected. An environmental testing firm should be contacted to conduct the tests and to recommend the extent of the repairs required.

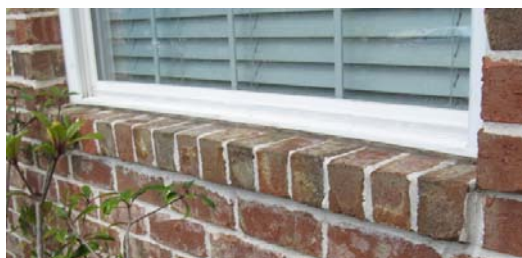
Figure 11

The brick window ledgers were improperly or inadequately sloped at most of the window penetrations (see figure 11 above). Proper industry installation requirements are that the ledgers slope a minimum of 15 degrees away from the house to allow the ledgers to drain completely. Some of the ledgers installed on the house actually sloped toward the house which will force water into the wall cavities. The ledgers should be removed and adequately sloped, at a minimum, new ledgers should be installed.

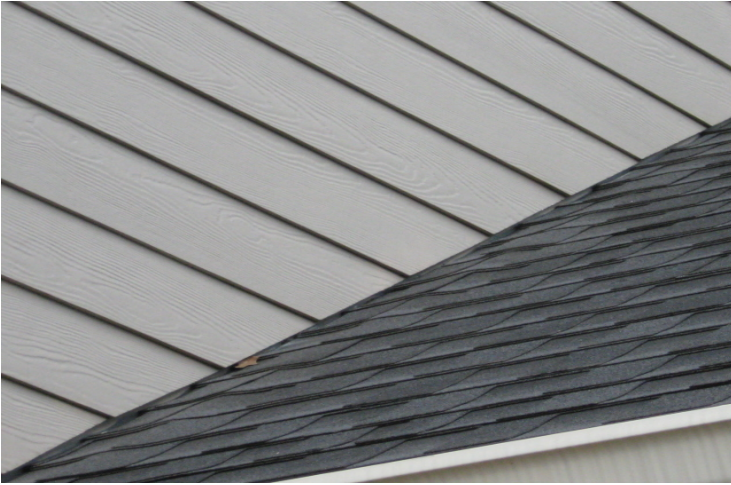
The wood fiber products siding was too close to the surface of the roof covering materials in some areas. The current building code and the manufacturer's installation instructions provide that a two inch clearance is required between the bottom of the siding and the surface of the roof. The clearance is required to prevent water on the roof deck from being absorbed into and damaging the siding and to prevent debris from being caught and trapped between the siding and shingles which could create dams. The siding should be trimmed to provide adequate clearance from the surface of the roof.

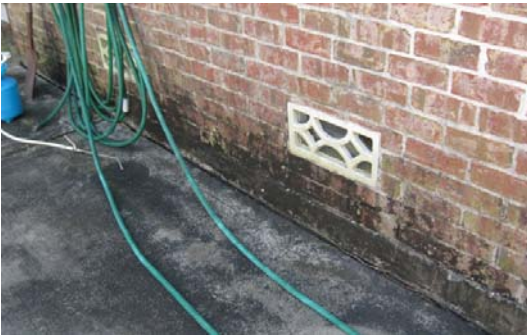
Mildew was noted on the exterior brick veneer indicating water penetration in the brick veneer. The sources of the water penetration should be determined and eliminated. Drains, such as weep holes should be installed or cleared so that the wall cavities can drain properly.

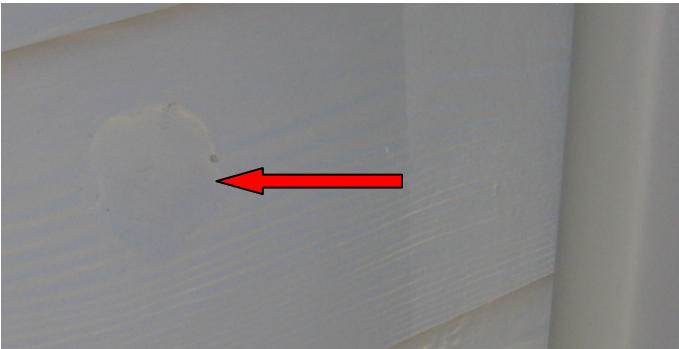
There was an improper patch in the wood fiber products siding of the garage. The damaged section of siding material should be replaced. The new section of siding material should be finished to match the existing structure.

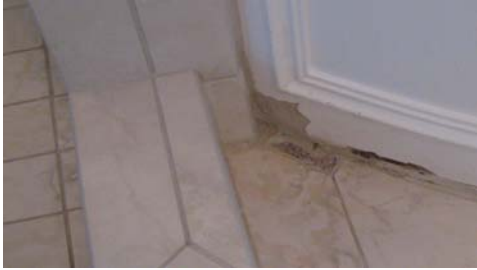
Deteriorated wood was found on the master bathtub skirt, etc. indicating the need for an examination by a qualified licensed pest control inspector. Presence or damage from termites, rot or other wood infesting organisms is not part of this report. Detection of wood infesting organisms is reserved by Texas Law to the structural termite inspection. All deteriorated material, regardless of the cause, should be removed and replaced with sound new lumber finished to match the existing structure.

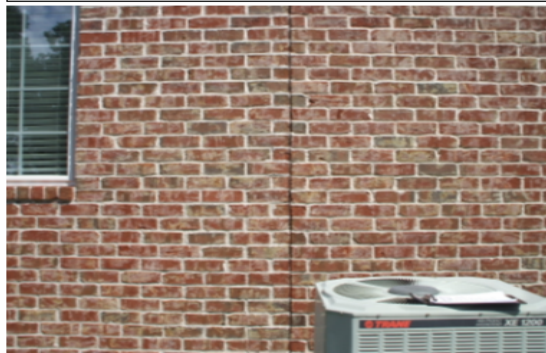
Comments: 1) Brick expansion joints on both sides of house need to be caulked.

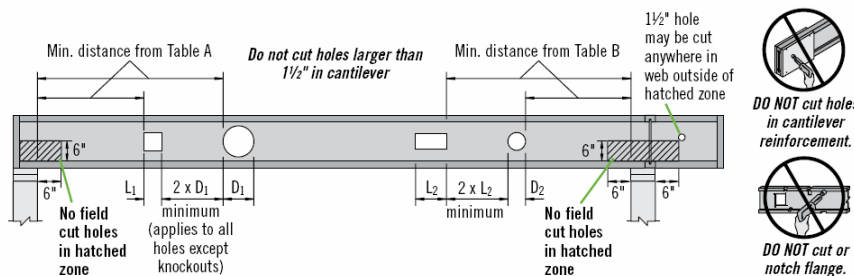
The engineered silent flooring joists were improperly bored in the garage. The joists should be removed and replaced with new joists installed according to the manufacturer's requirements for safety.

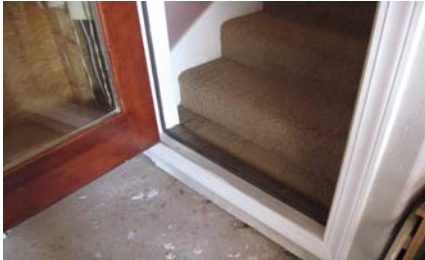
The stair risers were not uniform in size and the height of the first riser from the garage exceeded the maximum allowable riser height. This condition creates a hazard to the user of the stairs. The brain adjusts your stride to the height and depth of stairs and one step that is a different size can cause you or another user of the staircase to trip and fall. The risers should be made uniform in height for safety.

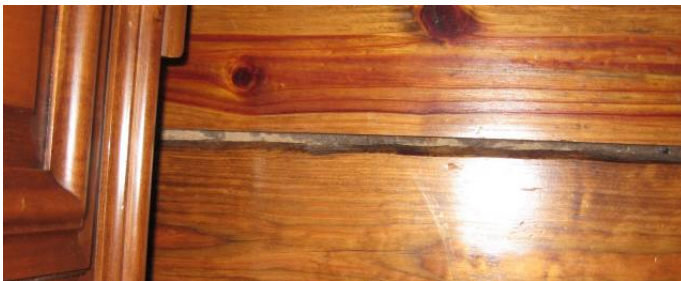
There were some excessive spaces between the wood flooring planks. As there is no subflooring in this installation, it is extremely important that the floor be well sealed as the floor is the only barrier between the air in the crawlspace and the air in the house. Air entering the house from the crawlspace will most likely be at a different temperature and will most often have higher humidity than the air in the house. This will cause the air conditioning systems to operate more often and will raise the humidity levels in the house. Higher humidity will increase the discomfort of the interior ambient air.

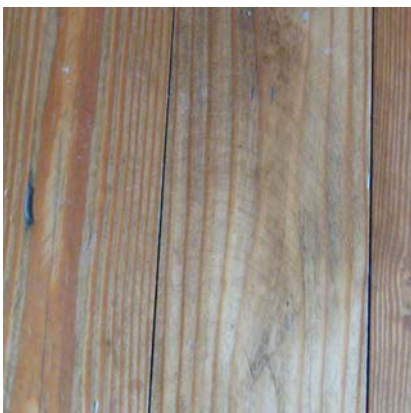
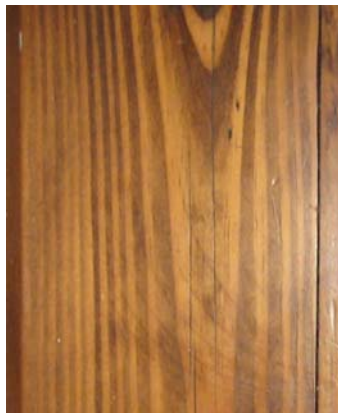
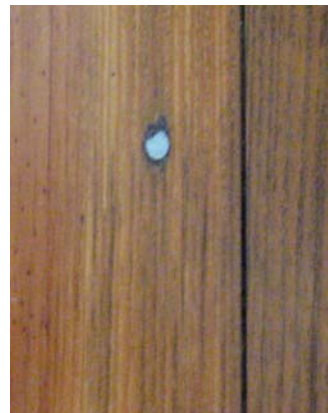
There were indications that the floors had been ground flat and there were some surface nails installed. This indicates that the flooring planks had cupped or crowned from excessive moisture. The floors should be inspected by a competent flooring contractor to determine if the floors need drying or sealing to prevent a reoccurrence of the deformation of the floors.
