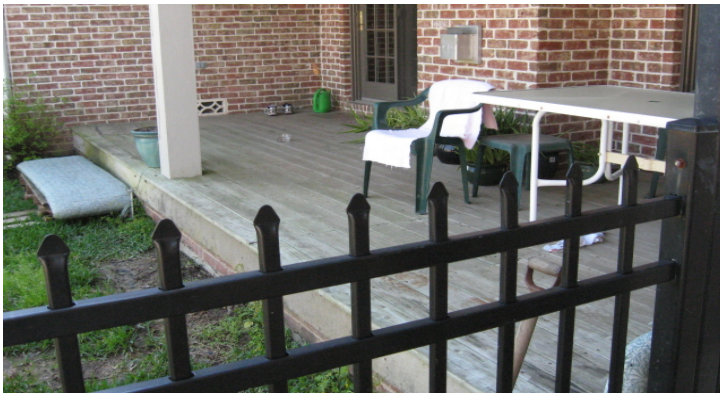
The surfaces of the front and rear wood decks were in contact with the brick veneer. Current building codes provide that the elevation of ground surfaces, sidewalks, porches, decks, patios or driveways, etc. cannot be closer than six inches to the elevation of the surface of the foundation or the bottom of the claddings of a house when the cladding is not masonry. Having the elevation of the deck raised so that the deck is in contact with the veneer can allow water to be trapped in or against the veneer and can allow water to splash and/or flow into the house. The elevations of the decks should be lowered or a space between the decks and veneer should be created to allow moisture to drain off the deck properly.
