**HOUSE SUB PANEL: The sub breaker panel was an exterior 125 Amp Cutler Hammer box with 60 Amp main disconnects. The service entrance conductors were #4 copper conductors. The interior wiring to the house was copper. The branch circuits were rated as follows:**

**GARAGE SUB PANEL:** The breaker panel was an interior 125 Amp Cutler Hammer box with 60 Amp main disconnects. The interior wiring to the structure was copper. The branch circuits were rated as follows:

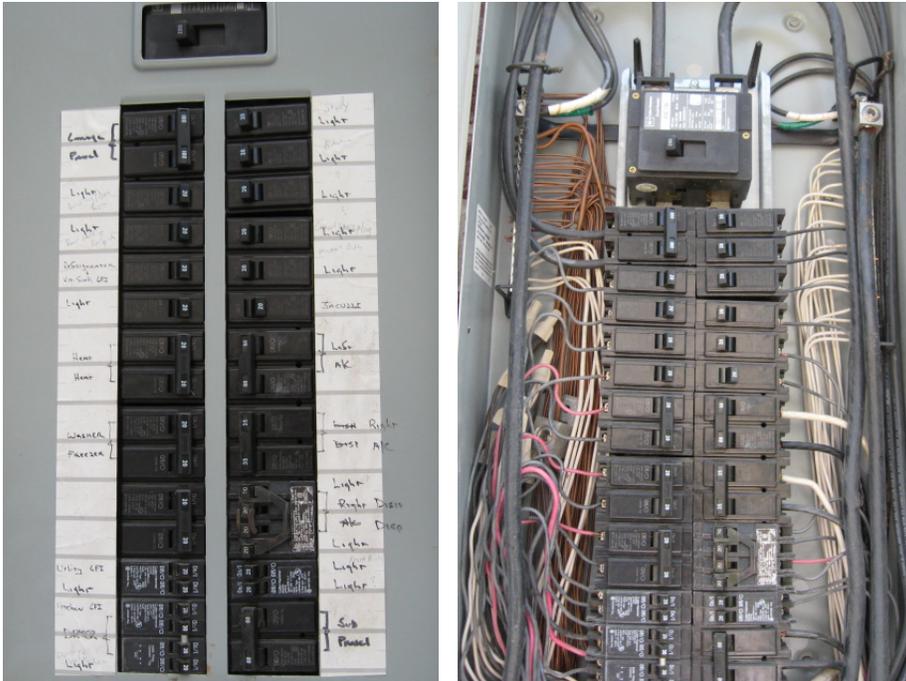
The circuits were not properly labeled or identified in the breaker panel. As the circuits were not identified, it could not be determined if the circuits were properly sized for the listed appliances. Over sizing on any appliance is a recognized fire hazard. The National Electric Code, Section 408.4, states that identifying circuits as ‘bedrooms or wall outlets or light switches’ is not adequate. Labeling must be specific as to which appliances are to be protected by the over current device. The circuits should be rated and certified by a competent electrician according to the listings of the appliances.

The grounded conductors (neutrals) and equipment and branch circuit grounding conductors were not separated on different bus bars. The current installation causes electrical flow on the bonding bar. While the International Residential Code (IRC) allows this installation, the manufacturer of the panel does not. In all codes, the most restrictive covenants control. The manufacturer intended the bonding bar to equalize differing electrical potentials. The grounded conductors and the grounding conductors should be connected to their respective bus bars to allow the proper operation of the bonding bar.

The main disconnect and the house sub panel were not properly bonded or grounded. This condition can put electrical potential on the equipment grounding conductors which can result in an electrical shock or fire hazard. The neutrals and equipment grounding conductors must be completely separated, the neutrals must be solely attached to the neutral bus bars and neutral conductors, the equipment grounding conductors to the grounding bus bar and grounding electrode conductors and the grounding bus bar must be bonded to the sub panel housing. The main panel and house sub panel should be properly bonded for safety.

**The panel appeared to be over-filled. Electrical components and conductors can fill an enclosure within strict limitations on the area used by the appliances. The flow of electricity generates heat and there must be ample air in which to diffuse the heat. The area limitations should be confirmed by an electrician or other areas created for splicing the conductors.**

**Neutral conductors were used as hot conductors and were not identified. All hot conductors are required to be identified by the use of any color other than white, gray or green or bare copper per Section 3307.3 of the International Residential Code (IRC). The conductors should be properly identified for safety.**

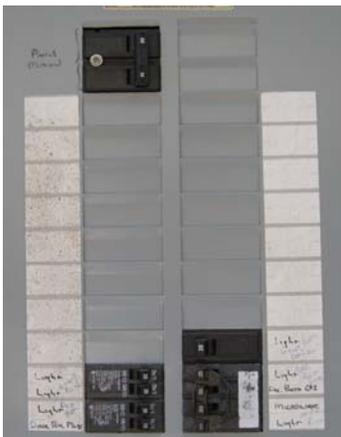
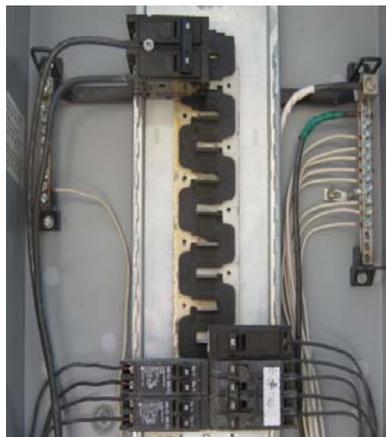
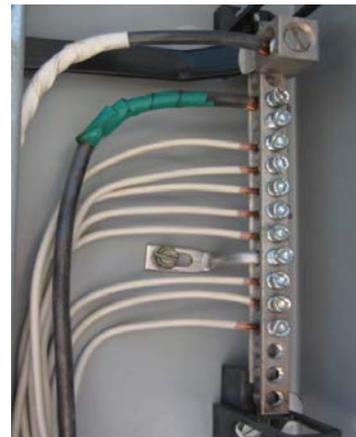
**The circuits were not properly labeled or identified in the breaker panel. As the circuits were not identified, it could not be determined if the circuits were properly sized for the listed appliances. Over sizing on any appliance is a recognized fire hazard. The National Electric Code, Section 408.4, states that identifying circuits as 'bedrooms or wall outlets or light switches' is not adequate. Labeling must be specific as to**

which appliances are to be protected by the over current device. The circuits should be rated and certified by a competent electrician according to the listings of the appliances.

There were no equipment and branch circuit grounding conductors present in the panel box. There were not enough equipment and branch circuit grounding conductors in the main panel to indicate that the grounding conductors were terminated in the main panel. The locations of the termination of the grounding conductors should be determined. The terminations of the grounding conductors should be made in the sub panel for safety.

The grounded conductors (neutrals) and the service grounding conductor were not separated on different bus bars. The current installation causes electrical flow on the bonding bar. While the International Residential Code (IRC) allows this installation, the manufacturer of the panel does not. In all codes, the most restrictive covenants control. The manufacturer intended the bonding bar to equalize differing electrical potentials. The grounded conductors and the grounding conductors should be connected to their respective bus bars to allow the proper operation of the bonding bar.

As noted in the “Main Panel” section, the sub panel was not properly bonded to the electrical system or connected to the earth grounding electrode. This condition should be corrected for safety.

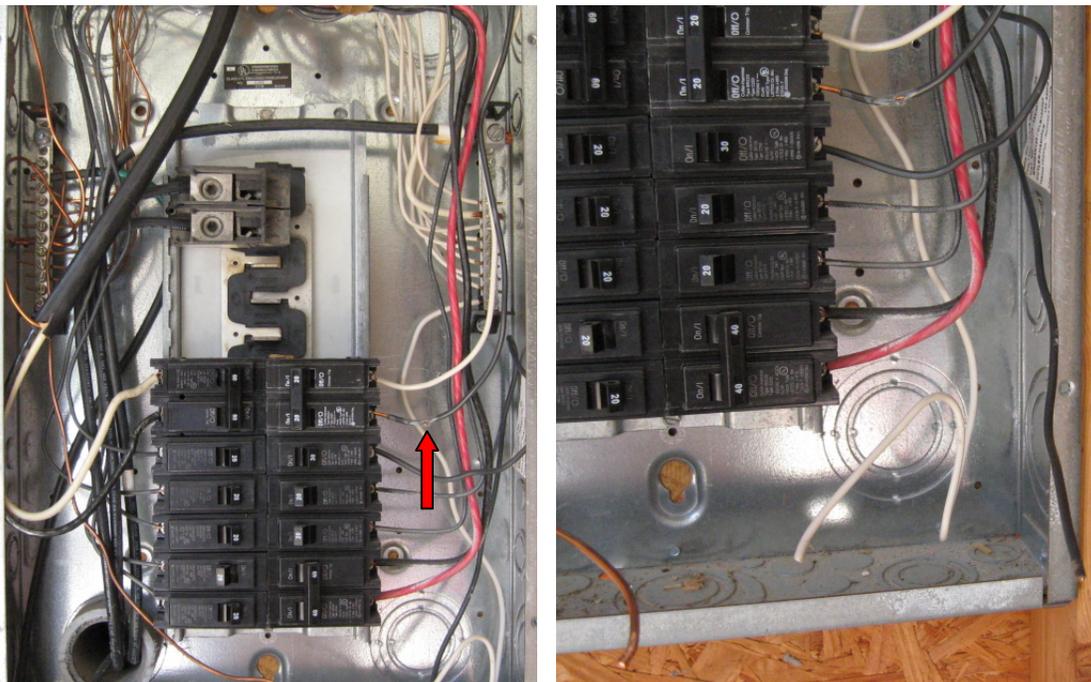
The conductors on the 30 Amp, 120 volt circuit had been cut and were terminated in the panel. The open ends of the ungrounded (hot) conductor and the grounded (neutral) conductor were in contact with the panel housing. The 30 Amp breaker had been turned off which relieved part of the hazard of live conductors being in contact with a metal housing however, grounded (neutral) conductors carry electrical current at all times. Had the 30 Amp breaker been operating, the panel box itself would have completed the electrical circuit. A fault or malfunction of the electrical equipment or conductors could also have caused a

circuit to have been created using the panel box. This was an extreme life/safety hazard. With your permission, I removed the conductors from the panel box. The photograph on the right above is of the terminations of the conductors after I had moved them out of the panel box.

The 30 Amp, 120 volt breaker was oversized for the #12 copper conductors attached to it. If the circuit is reestablished, either #10 copper conductors will need to be used in the circuit or the breaker will need to be replaced with a breaker rated for the size of the conductor.

The insulation was split on one of the ungrounded (hot) conductors in the panel. The uninsulated section of the conductor should be removed. A properly insulated conductor should be installed. Insulation is the inhibitor that keeps electrical current on its circuit. Failure of the insulation can allow a fault or short to occur.

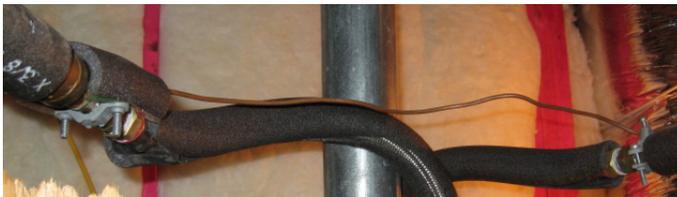
The bonding cable on the water supply pipes was improperly installed. The bonding conductor was attached to the water pipes but the connection to the water pipe system was made on the tank side of the shutoff valve. Most valves are plastic lined or the pipe threads are treated when the unions are made. The linings and many of the treatments do not conduct electricity. The bonding conductor should be moved to the supply pipe to equalize electrical potentials in the piping systems.

The clamp material for the bonding conductor was not compatible with the water supply pipes. The differences in material cause electrolysis which will destroy the pipes. The clamps should be made of the same material as the pipes to prevent Galvanic action.

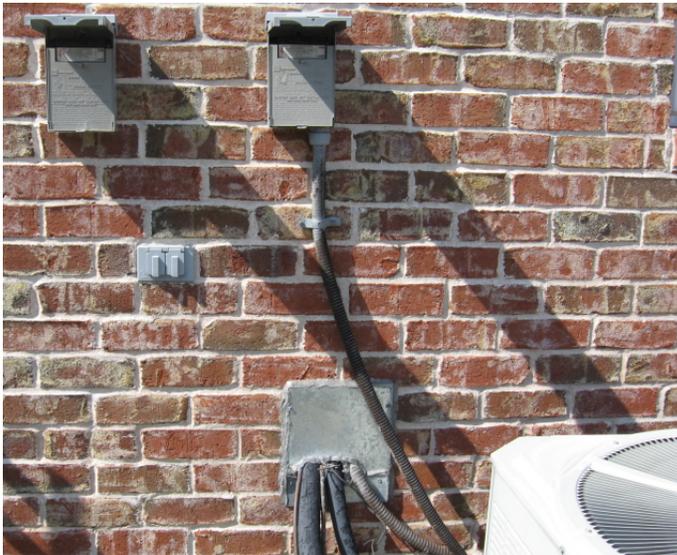
**There was inadequate clearance in front of the air conditioning mechanic's disconnects at the air conditioning condensing units. All energized electrical equipment and panelboards are required to have unobstructed access 36 inches deep in front of the equipment and 30 inches wide, at a minimum. Proper access for the disconnects should be provided according to Section E3305.2 of the IRC and Section 110.26(A) of the National Electric Code.**

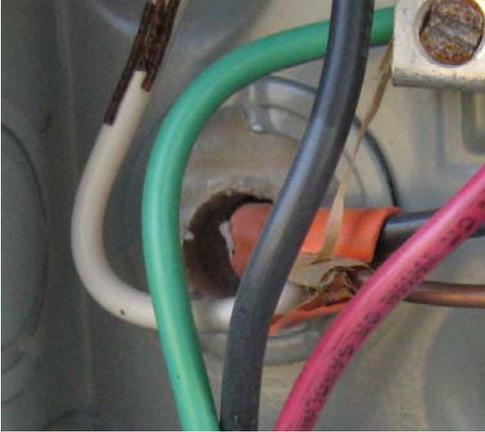
**A cable clamp was missing from the garage air conditioning condensing units mechanics disconnect. Cable clamps protect the insulation on the conductors as they pass through the metal box. A cable clamp should be installed for safety.**

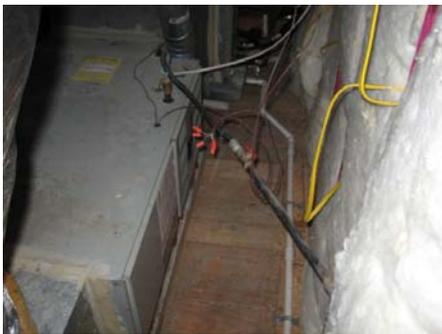
**FIRST STORY UNIT:** The work platform installed at the unit was inadequate. A work platform a minimum of 30 inches wide and 30 inches deep should be installed on each side of the unit for safe access to the unit as required by the manufacturer’s installation instructions and by the model building codes.
