■ □ □ ■ **B. Cooling Equipment**

Type and Energy Source: Central Split, Electricity

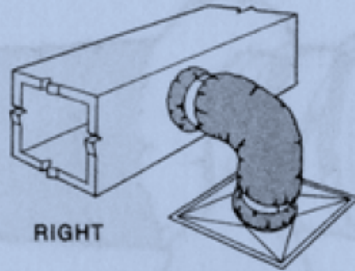
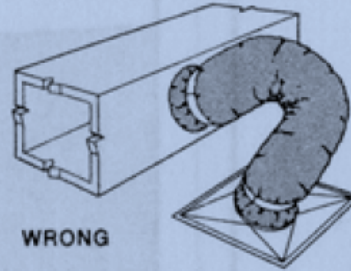
CONDITIONED AIR DISTRIBUTION SYSTEM: Pinched and misshapen flexible ducts were noted throughout the attics of the house and garage. It is well known that reducing or changing the shape of a pipe or channel causes turbulence which increases the pressure in the pipe or channel but reduces flow through the pipe, a phenomenon that you may have used in pinching a garden hose to reduce or eliminate water flow from the hose. For some reason, HVAC contractors contend that this well known and documented fact does not occur in flexible air ducts. It does. The ducts should be properly aligned and supported. The turns in the ducts should be gradual so that the duct is bent and distorted as little as possible. This will help increase the volume of air flowing into the house and may relieve the pressures on the air conditioning equipment. The temperature and humidity levels should be consistent throughout each story of the house.

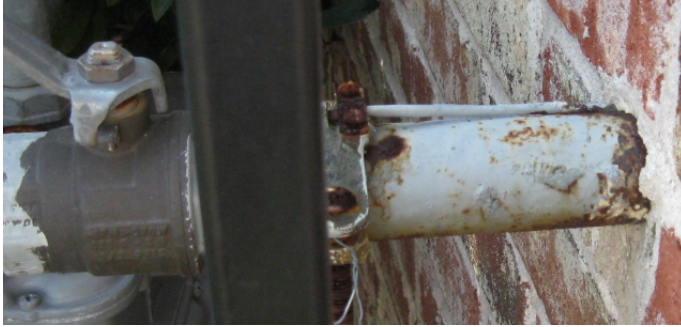
NATURAL GAS PIPE: The natural gas pipe penetration through the brick veneer is required to be sleeved so that no friction between the brick veneer and the gas pipe can develop and so that corrosives from the brick veneer cannot attack the gas pipe. The penetration of the gas pipe through the brick veneer should be sleeved for safety.

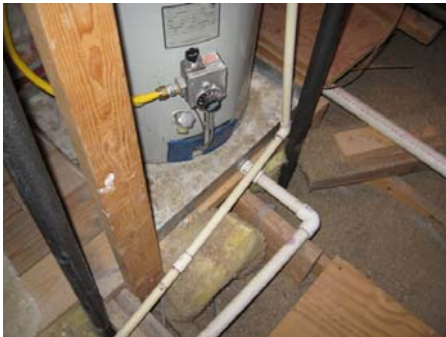
FIRST STORY UNIT: There work platform installed at the unit was inadequate. A work platform a minimum of 30 inches wide and 30 inches deep should be installed on each side of the unit for safe access to the unit as required by the manufacturer’s installation instructions and by the model building codes.

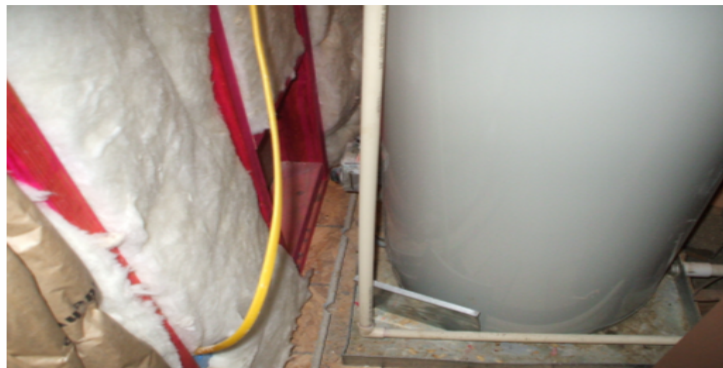
Comments: 1] The control and firebox on the 30 gallon water heater faces the wall and cannot be inspected. Code requires 30" of clearance in front of the firebox. This unit needs to be rotated 180degrees. 2] Rust accumulation on top of the burner on the 50 gallon water heater needs to be cleaned off.

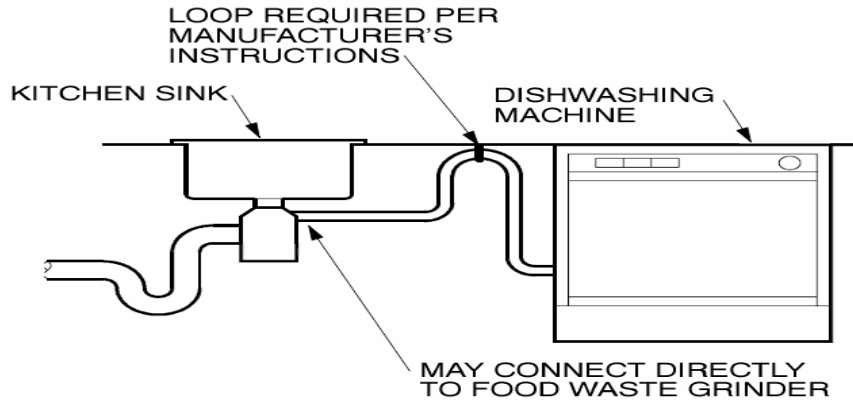
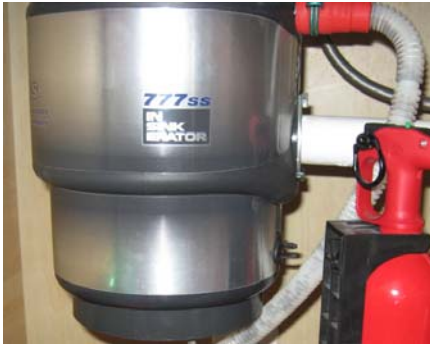
There was no anti siphon loop or mechanical air gap in the drain pipe. An air gap or anti siphon loop is used to prevent backflow of contaminated water and bacteria from the disposer or plumbing drain back into the dishwasher. Many models come with backflow valves, but the anti siphon loop or mechanical air gap is still required. An anti siphon loop is created by forming an upside down “U” in the drain hose. The “top” of the “U” must be in contact with the bottom of the counter. The hose is the tied in place, usually to the underside of the sink or to the faucets.

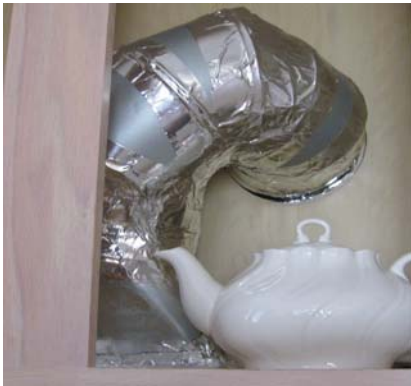
The range vent discharge pipe was improperly routed. The vent pipe contained a low spot that would trap grease and debris. This condition would increase the chances of the materials and debris trapped in the vent pipe catching fire. The vent pipe should be rerouted so that the low spot or trap is eliminated.
