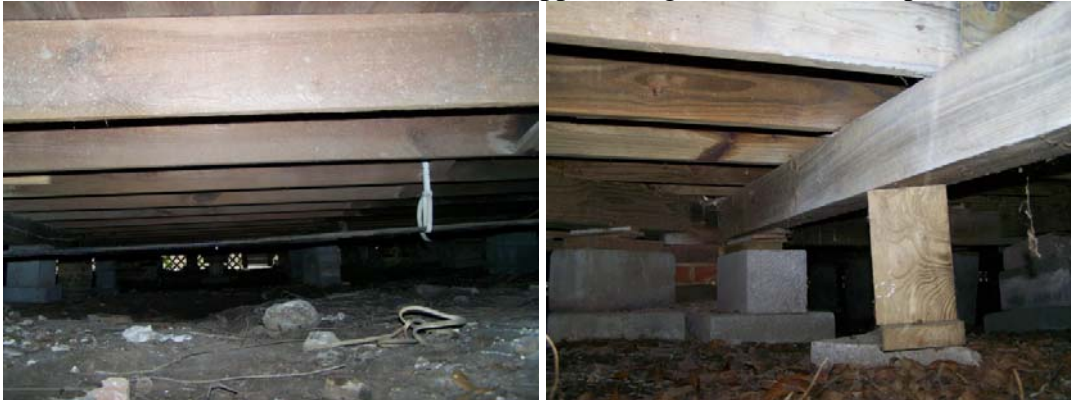
-The pier and beam foundation shows settling to the interior piers. In several rooms settlement is measured toward the interior of the home. This structural movement has caused several interior sheetrock cracks which are seen in the walls. Note: the foundation has been previously shimmed and leveled in areas.

-The 2x8 floor joist have a long span under the living room and dining room. Some deflection is measured in the joist recommend installation of a girder.

-The 2x6 block which has been used to support the girder should be replaced with a block pier.

Repair method Settlement is generally alleviated by mechanically raising the beams, removing existing piers, sustaining the beam position and installing new supporting piers. Foundations are also leveled by using shims on the existing piers. The shimming process will not guarantee against future recurrence of interior settlement because the problem has not been resolved. The shimming process is relatively inexpensive and, as the rate of settlement decreases with time, the bearing soil beneath the pier will eventually compact.

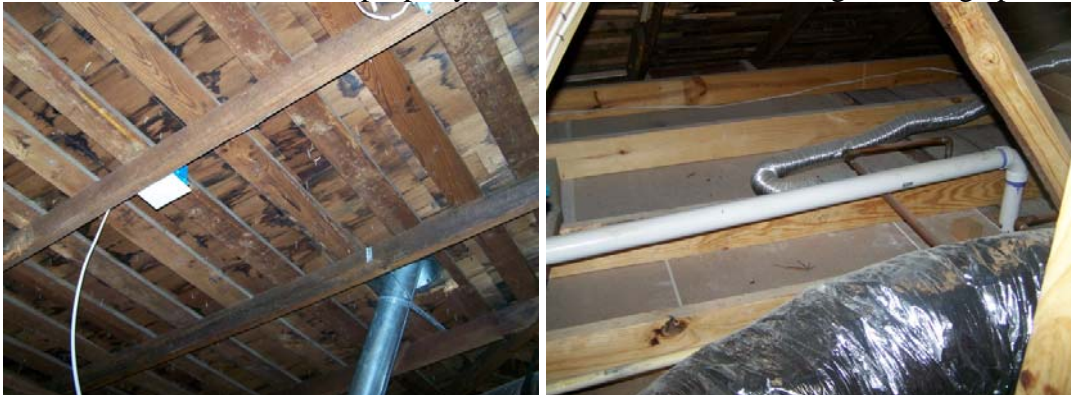
-A depression is observed at the front and rear slope of the roof and in the front valley over the master bedroom as seen from the exterior.

-The cause is excessive spans in the 2x4 rafters recommend installation of addition purling bracing and sistering the rafters when the roof covering is replaced.

-Ceiling joist over the master bedroom have been replaced.

-The attic latter needs to be properly secure with 16D nails through the hinge plates.

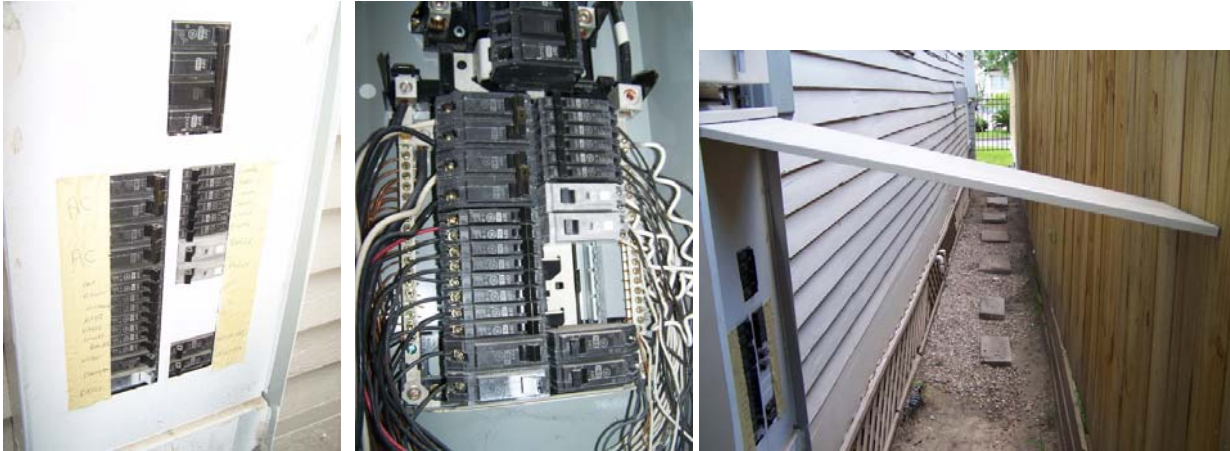
-The breaker box cover strikes the fence when opened.
