PROPERTY INSPECTION REPORT

By:	Fred Willcox	TREC License No. 160	August , 2007	
	File No. 20068	713-461-0009

STRUCTURAL INSPECTION

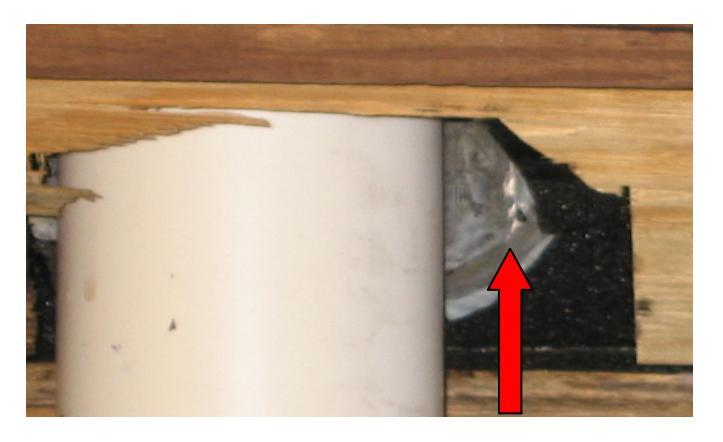
There were holes in some of the roof jacks. Holes in the roof jacks can allow water to enter the structure. The damaged roof jacks should be replaced.

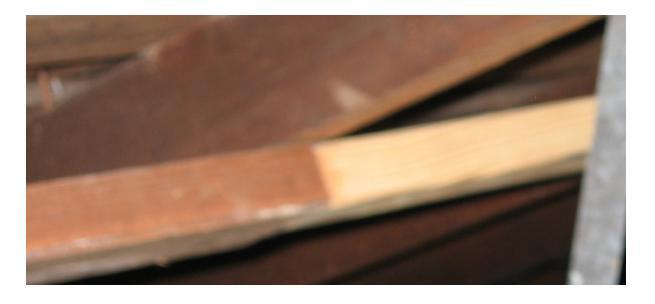
The purlins were improperly installed. Purlins are structural supports used to break the span of the rafters in order to keep the rafter from sagging. All structural members deflect under their own load. As loads on the member and the horizontal length (span) of the member are increased, the deflection increases. The purlins were installed with the wide part of the board against the bottom of the rafters. The equation that defines the stiffness of a board or beam is 1/12 the base multiplied by the height cubed. Merely turning a 2 X 4 up on its edge increase its stiffness by a factor of approximately eight. The purlins should be reinforced to provide proper support to the rafters.

The junctions of the purlin sections were not reinforced making the ends of each of the sections limber. The junctions of the different sections of purling material should have been made over a strut or the ends should have been reinforced so that the different sections acted as one board.

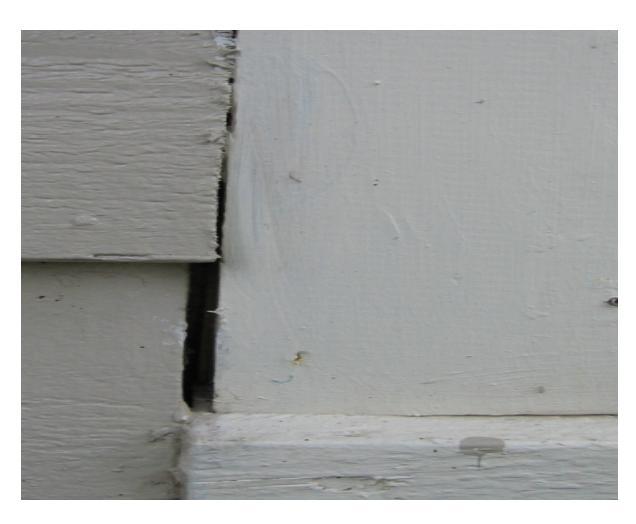
The junctions of the siding with the wind and door frames were not sealed. These openings allow moisture into the wall framing behind the siding. These junctions should be sealed with a quality, water proofing adhesive to prevent further water penetration.

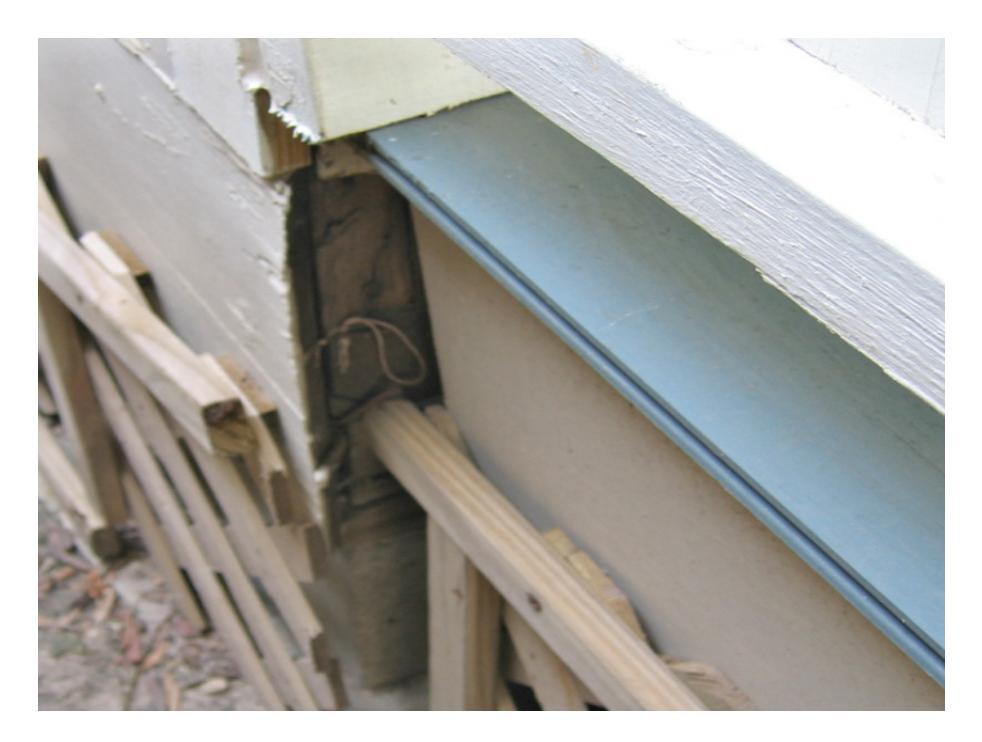
A section of trim was missing from the west side of the front porch junction with the south wall of the house. The missing trim section should be replaced. The new trim section should be finished to match the existing structure.

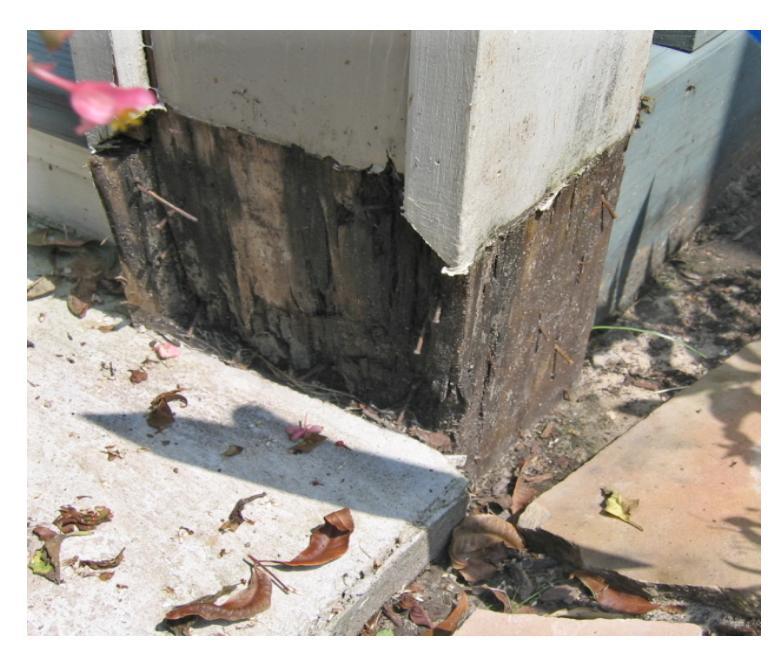
The inspection of the foundation did not include a full examination of the under structure exposed in the crawl space. Access openings in the chain wall or the height of the foundation above the ground were inadequate for this inspector. Examination of the wooden members for decay or damage is part of the Pest Control Inspection. Damaged or decayed areas should be noted in their report. Deteriorated wood was noted in the in the sill along the

north wall of the house. Only a portion of the sill appeared to have been deteriorated. All decayed members should be identified and removed. Sound, new lumber should be installed in place of the decayed members in the foundation framing and flooring systems.

Deteriorated wood was found on the exterior front porch column and on the foundation framing sill along the north wall of the house, etc. indicating the need for an examination by a qualified licensed pest control inspector. Presence or damage from termites, rot or other wood infesting organisms is not part of this report. Detection of wood infesting organisms is reserved by Texas Law to the structural termite inspection. All deteriorated material, regardless of the cause, should be removed and replaced with sound new lumber finished to match the existing structure.

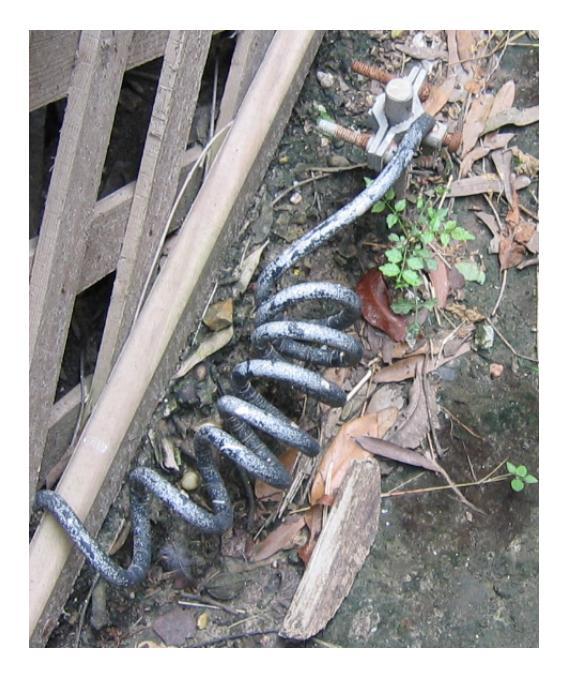
The grounding electrode conductors to the two grounding system made electrodes were not protected against physical damage. The conductors must be protected so that they are not cut or damaged. Damage to the grounding conductor(s) could result in the loss of the earth grounding of the electrical system.

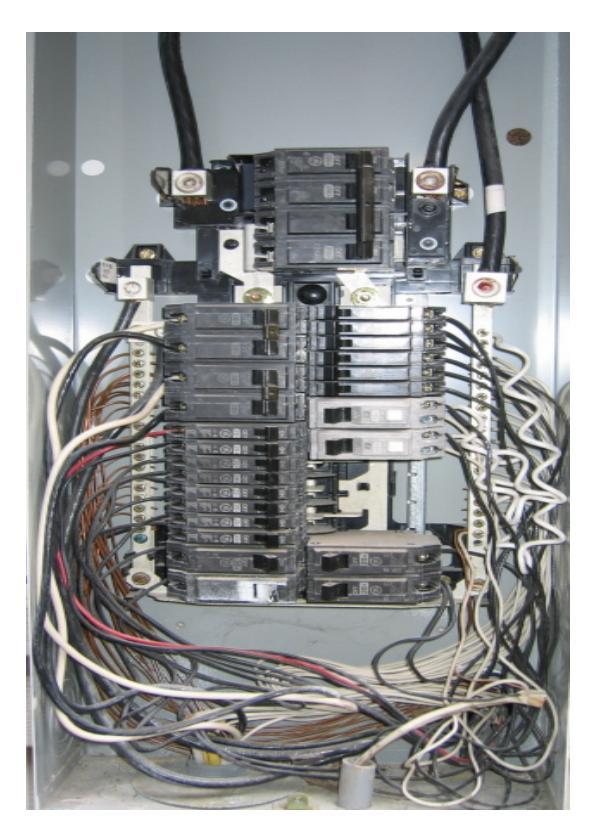
The circuits were not properly labeled or identified in both units. As the circuits were not identified, it could not

be determined if the circuits were properly sized for the listed appliances. The National Electric Code, Section 408.4, states that identifying circuits as 'bedrooms or wall outlets or light switches' is not adequate. Labeling must be specific as to which appliances are to be protected by the over current device. The circuits should be rated and certified by a competent electrician according to the listings of the appliances.

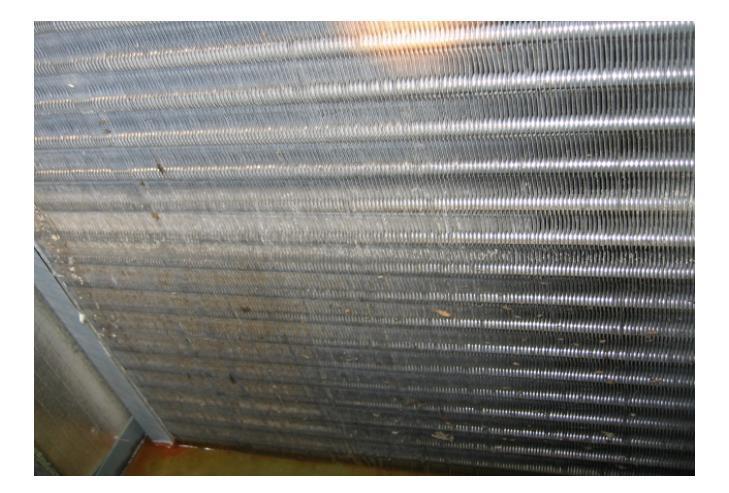
The condensing coil units were dirty. The coils should be cleaned. The fins should be straightened. The dirt should be removed from the coil. Restrictions in the flow of air through the coil and fins prevent the compressor from discharging the heat from the house into the atmosphere properly and reduce the efficiency of the unit. It also raises the amperage use of the unit and increases the cost of operating the system.

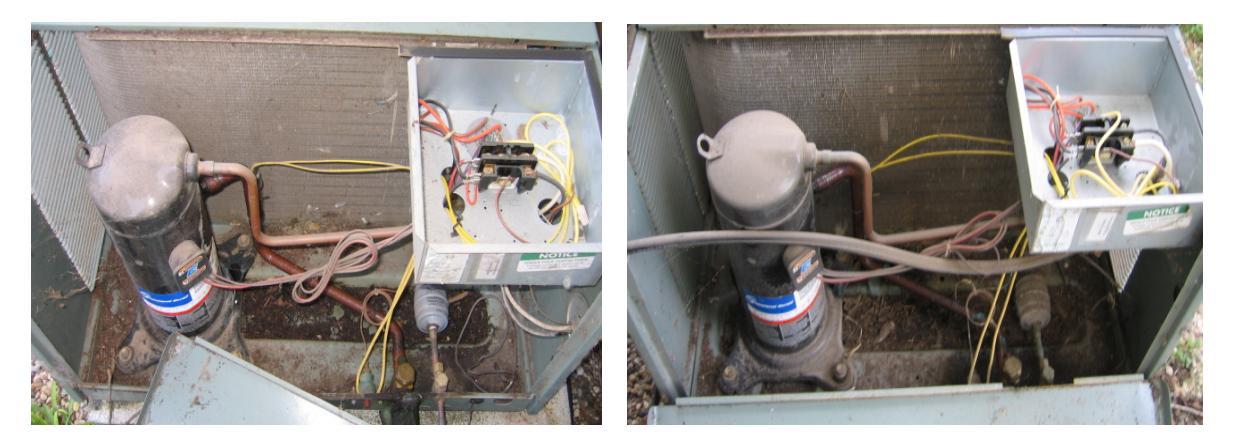
Cable clamps were missing from the interior electrical areas of each of the condensing units. Cable clamps protect the insulation on the conductors as they pass through the metal box. Cable clamps should be installed for safety.

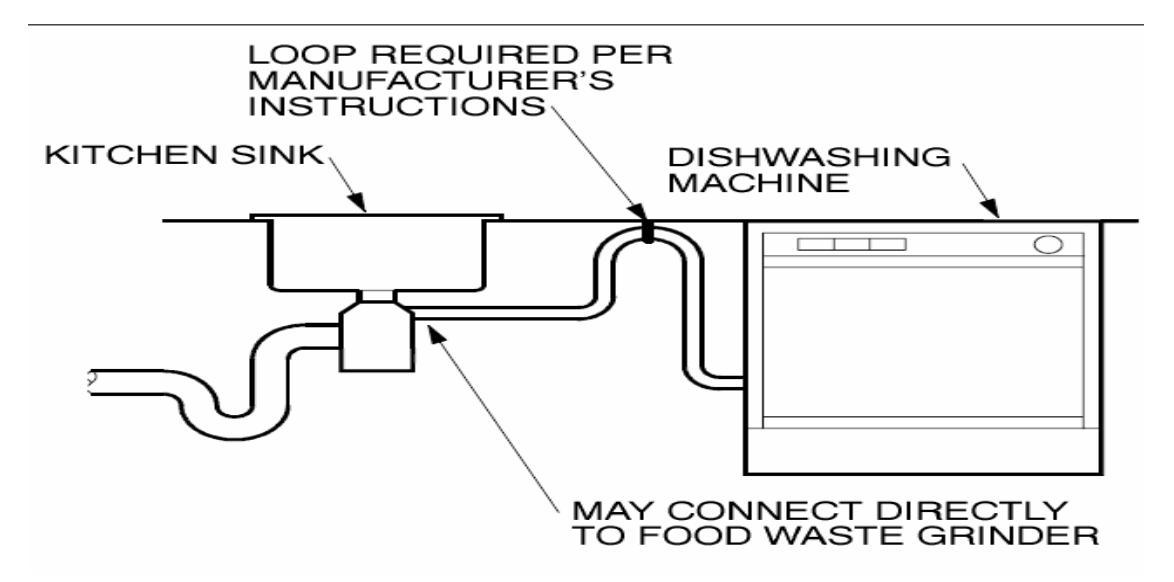
There was no anti siphon loop or mechanical air gap in the drain pipe. An air gap or anti siphon loop is used to prevent backflow of contaminated water and bacteria from the disposer or plumbing drain back into the dishwasher. Many models come with backflow valves, but the anti siphon loop or mechanical air gap is still required. An anti siphon loop is created by forming an upside down "U" in the drain hose. The "top" of the "U" must be in contact with the bottom of the counter. The hose is the tied in place, usually to the underside of the sink or to the faucets.
