# **PROPERTY INSPECTION REPORT**

Concerning:		Missouri City, Texas		
By: Fred Willcox		TREC License No. 160		
	File No.	713-461-0009

The inspection was of a two story, single frame dwelling under construction. The house was in the framing stage at the time of the inspection.

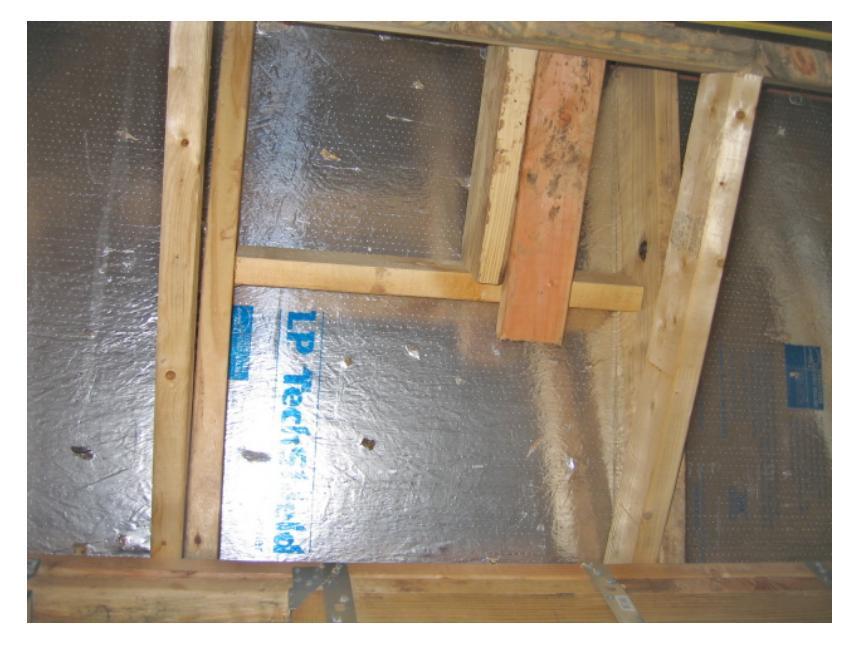
Several of the valley rafters and hip rafters were notched. Valley rafters are tension members, as defined by the code, and cannot be notched. The bottom of the valley rafter is in tension and the notch effectively removes the bottom section of the valley rafter from the board. This reduces the section of the board and may render the valley rafter inadequate. The notched valley rafters should be replaced. The notches in the hip rafters reduce the section of the hip rafters and decrease the hip rafter's ability to withstand separation. The notched hip rafters should be replaced.

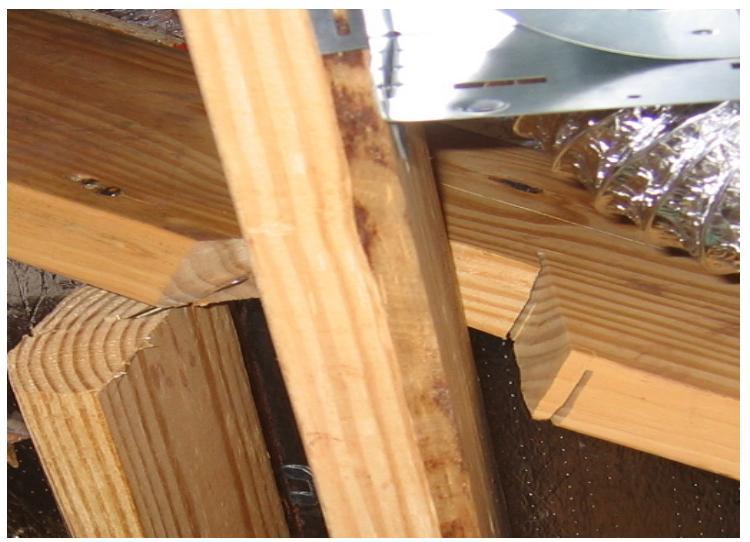
A brace on a valley was installed less than 45 degrees from the horizontal. This installation merely allows the strut or brace to rotate down when loaded by the roof. The strut or brace should be removed and replaced with a brace installed at the proper angle, which ideally should be perpendicular to the valley rafter.

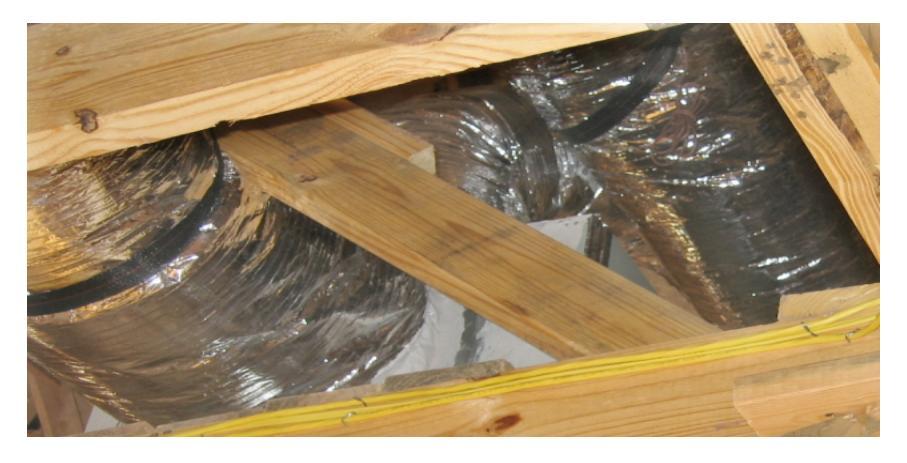
Some of the ceiling joists and/or roof rafters were offset more than 5 inches from the studs. The IRC, section R602.3.3 requires that all joists be located within 5 inches of the studs as the stud plates are not structural beams or headers and are not capable of transferring loads without deflecting.

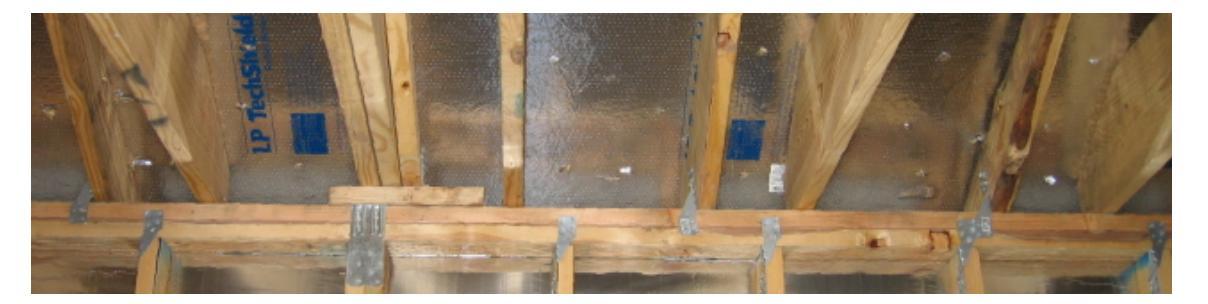
There were "lay down" valley rafters used to support the jack rafters on the rear of the house. A lay down rafter is improper for several reasons. The use of the lumber under this type framing is thought to be considerably weaker than the use of a valley rafter as the board is laid on its wide side and resists bending on its narrow side. The stiffness of a structural member is primarily determined by its depth, not its width. Section R802.3 of the International Residential Code (IRC) requires that all valley rafters be constructed as beams. Second, a common rafter cannot be used to support another common rafter, which is what happens with this type valley. Third, the system is structurally indeterminate. The forces cannot be resolved or their magnitude evaluated. Properly constructed valley rafters should be installed.

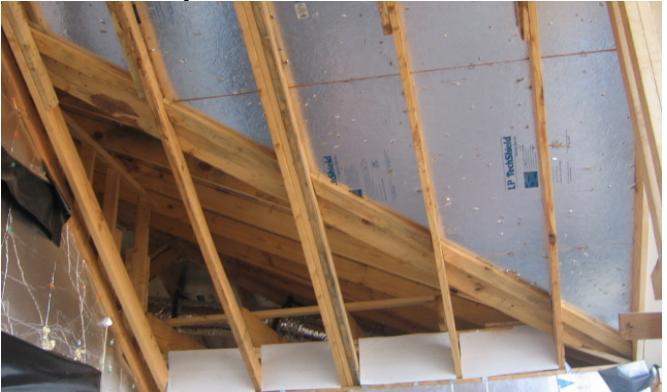
The ends of the jack rafters were square cut and were not cut to fit properly against header of the chimney chase. This does not allow for proper transfer of loads and the loads are transferred only through the shear strength of the nails. The jack rafters should be repaired.

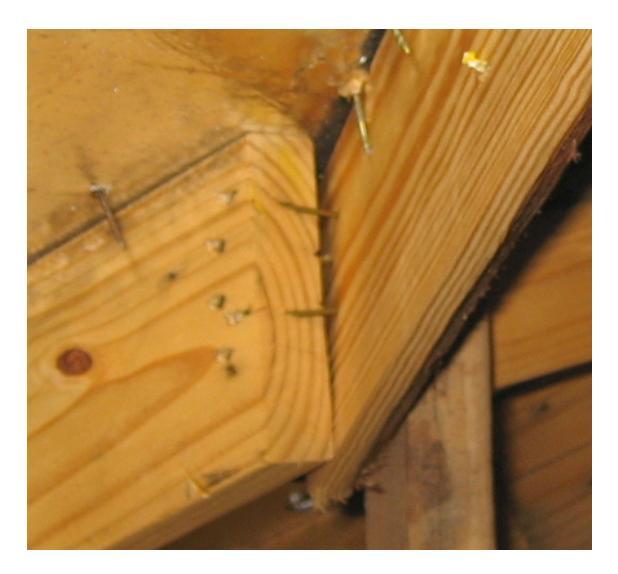
There were only single headers at the opening for the chimney chase. The openings are required to be framed with doubled headers. The single headers should be replaced with double headers.

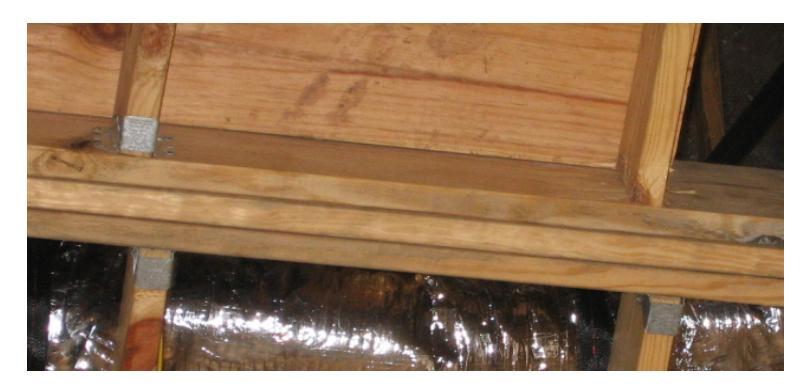
There were missing joist hangers and some of the joist hangers were undersized for the joists used. Joist hangers are required to be as deep as the joist. Joist hangers should be properly installed in all required areas.

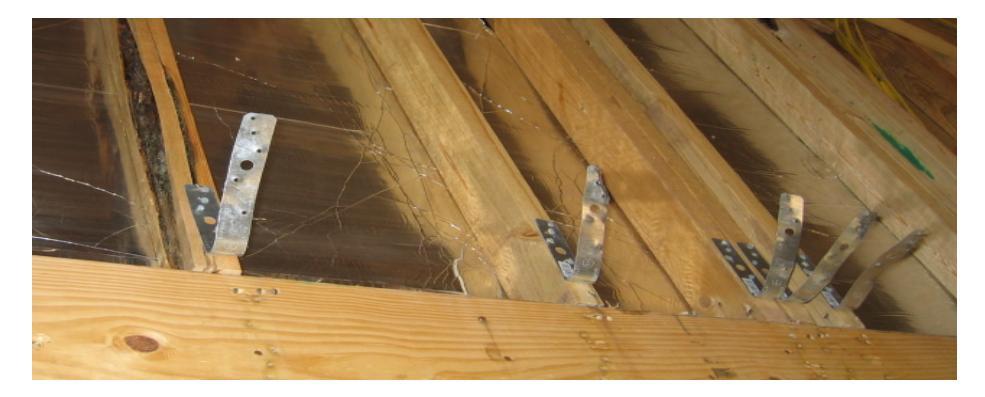
All high wind loading straps were not connected. All high wind loading straps should be properly fastened to the framing members.

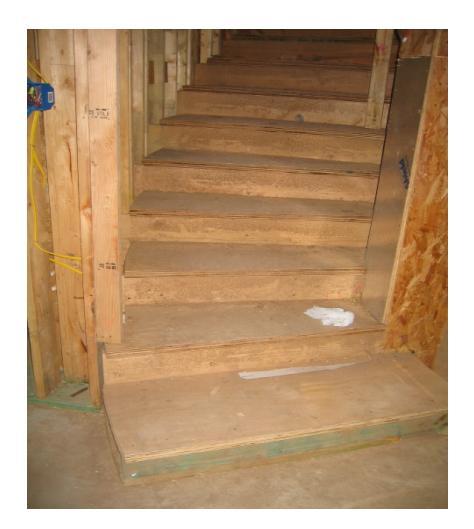
The stair risers and treads were not uniform in size. This condition creates a hazard to the user of the stairs. The brain adjusts your stride to the height and depth of stairs and one step that is a different size can cause you or another user of the staircase to trip and fall. The risers should be made uniform in height for safety.

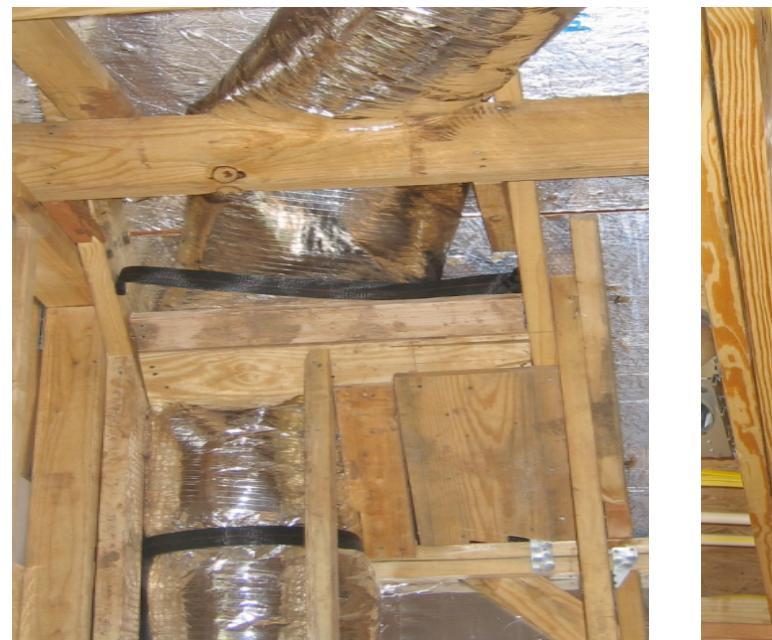
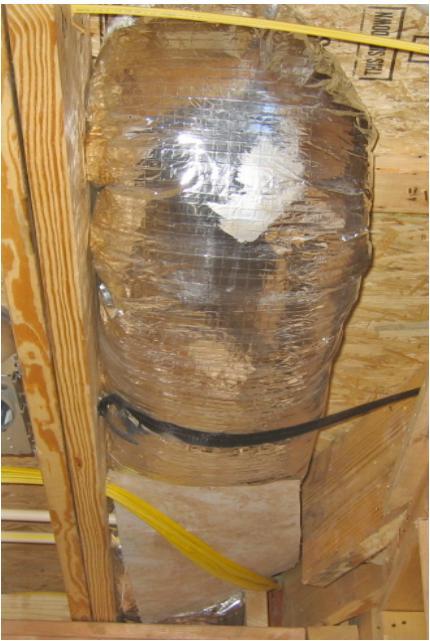
CONDITIONED AIR DISTRIBUTION SYSTEM: Pinched and misshapen flexible ducts were noted throughout the attic. It is well known that reducing or changing the shape of a pipe or channel causes turbulence which increases the pressure in the pipe or channel but reduces flow through the pipe, a phenomenon that you may have used in pinching a garden hose to reduce or eliminate water flow from the hose. For some reason, HVAC contractors contend that this well known and documented fact does not occur in flexible air ducts. It does. The ducts should be properly aligned and supported. The turns in the ducts should be gradual so that the duct is bent and distorted as little as possible. This will help increase the volume of air flowing into the house and may relieve the pressures on the air conditioning equipment.
