PROPERTY INSPECTION REPORT

(Name of Cl	lient)		
Concerning:				Houston, T	exas
		(Address or Other Identification	n of Inspected	Property)	
By:	Fred Willcox	Professional Inspecto	or #160	February, 2009	
	(Name and I	License Number of Inspector)			(Date
	File No	713 461 0000 m	www.will	ovingnostions our	n

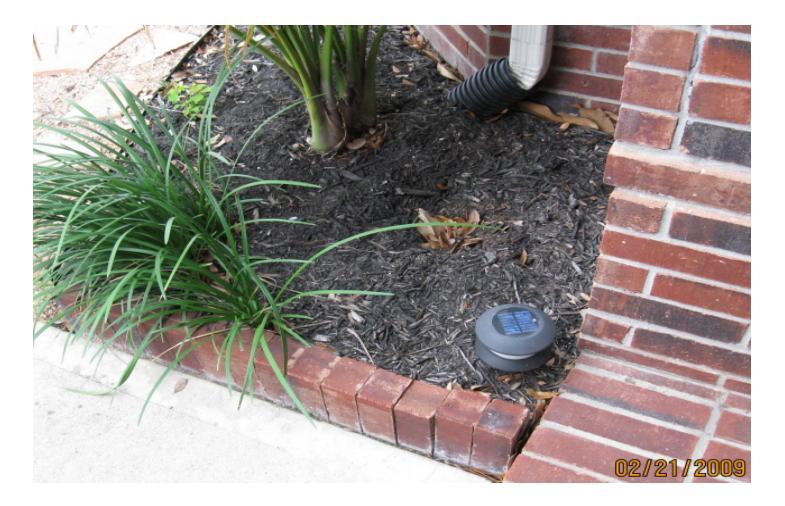
<u>Deficiency:</u> The front flower beds were sculpted so that the elevations of the beds appeared to be higher that the elevation of the foundation and the flower beds sloped toward the house.

<u>Information:</u> Current codes provide that all ground water within ten feet of the foundation must drain away from the house. The flower beds should be lowered and the beds should be sloped to provide positive drainage of ground water away from the foundation.

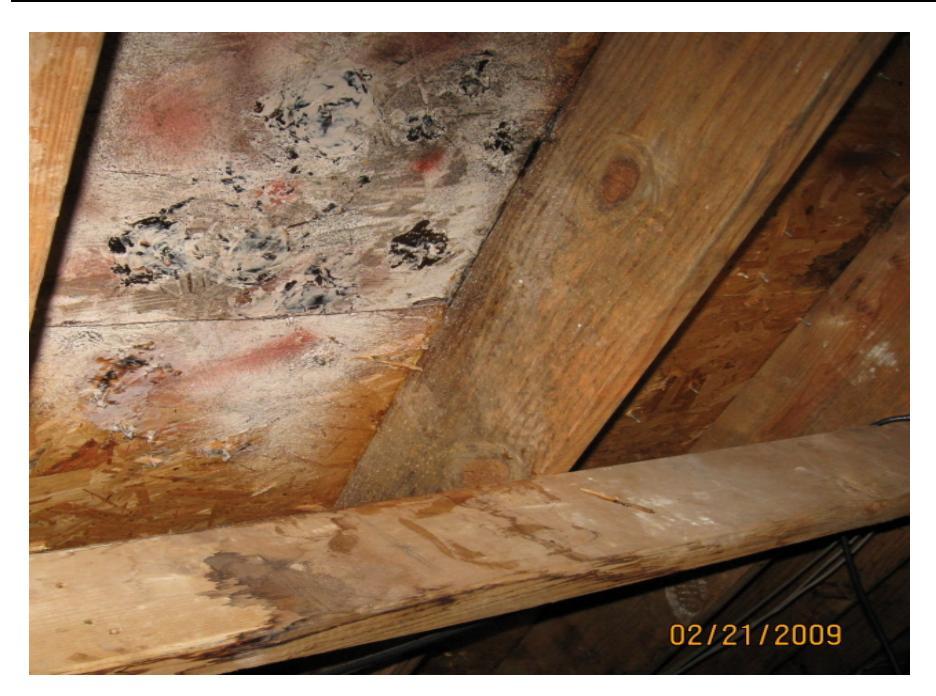
<u>Deficiency:</u> Water stains, indicating the possibility of active roof leaks, were found on the roof decking materials and framing members in the attic, etc.

<u>Information</u>: The source(s) of the water stains should be determined and repaired. While the stains may be from old leaks, it is assumed that if the roof covering materials had been repaired that the stain roof decking, ceiling or wall covering materials would have also been repaired.

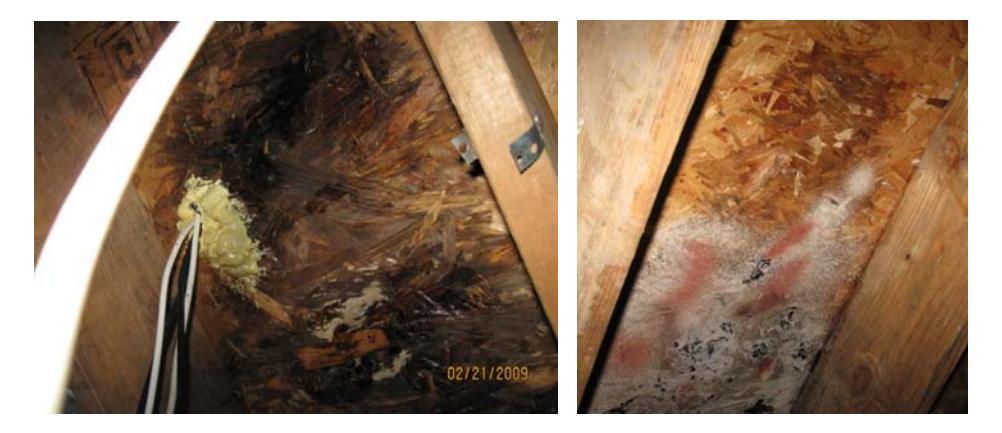
<u>Deficiency:</u> Decayed roof decking materials were noted on the roof decking materials in the attic and along the drip and rake edges of the roof.

<u>Information</u>: The extent of the decayed materials could not be determined. All decayed roof decking materials should be replaced. For further information, see the paragraph on deteriorated materials in the "Walls" section of this report.

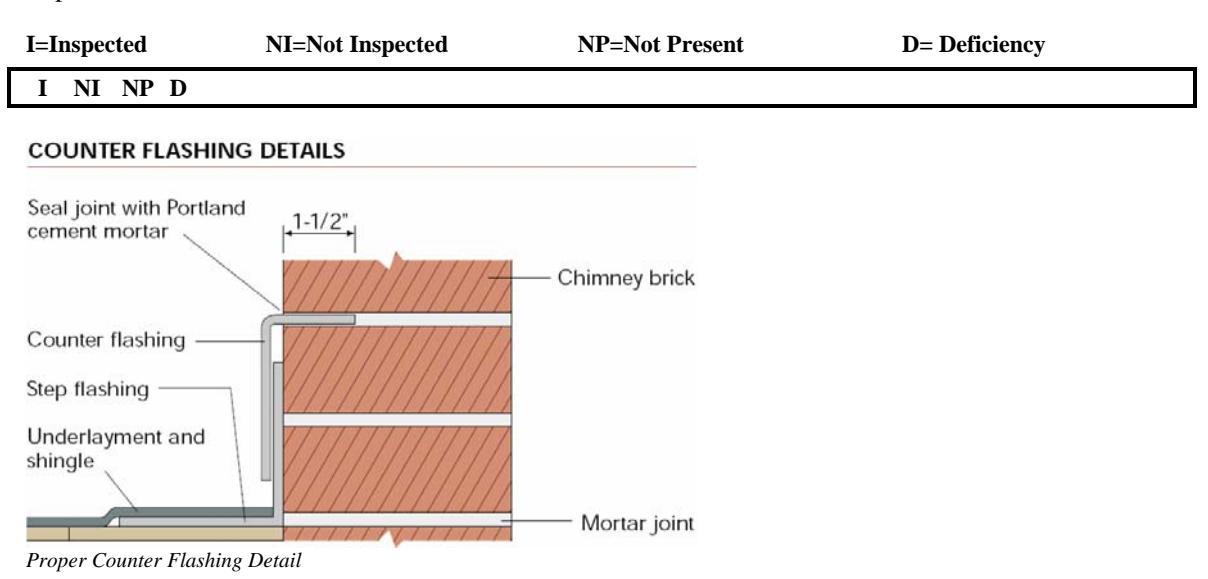
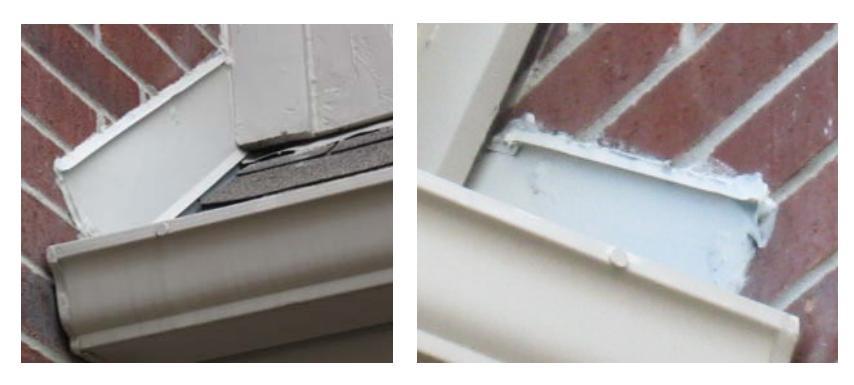
Deficiency: The counter flashing appeared to be improperly installed in some areas.

<u>Information</u>: The tab on the counter flashing is supposed to be cut back into the brick veneer to create a positive seal over the flashing. Instead, the edge of the tab was placed against the exterior of the veneer and the counter flashing was nailed to the veneer. A sealant was then applied to the opening that still exists between the top of the counter flashing and the brick veneer. If sealants were capable of preventing leaks over the life of the roof, then metal flashing would not be necessary. This installation will leak much sooner than properly installed counter flashing would. If the flashing is not cut into the brick veneer, maintenance will need to be performed on a periodic basis.

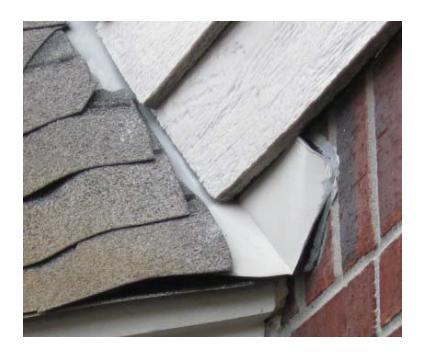
<u>Deficiency:</u> Counter flashing was not installed at the junctions of the brick veneer with the roof over the garden window.

<u>Information</u>: The purpose of counter flashing is to seal the opening between the tops of the step flashing sections and the brick veneer. The tab on the counter flashing is supposed to be cut back into the brick veneer to create a positive seal that covers the gap between the top of the flashing and the side of the brick. Flashing and counter flashing must be installed for the roof to perform properly without continual maintenance over its lifetime.

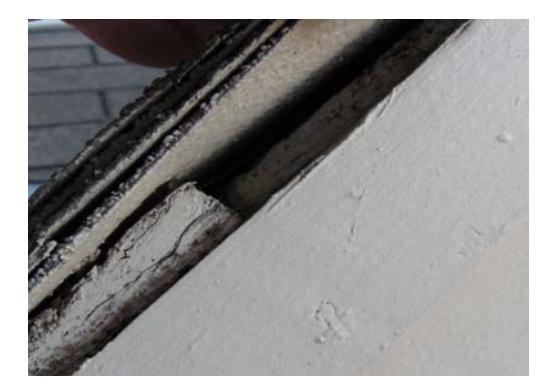
Deficiency: There were offsets in the roof decking materials along the rakes.

<u>Information</u>: These offsets create openings for water to enter the structure. These offsets should be sealed to prevent water penetration.

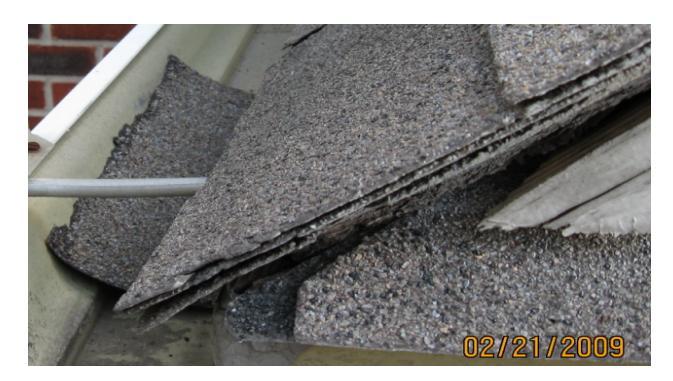
<u>Deficiency:</u> There was a shingle tab in the front gutter.

<u>Information</u>: It could not be determined if a tab was missing from the surface of the roof at the time of the inspection as all of the surfaces of the roof were not visible. It is possible that the tab was from damage to the roof that had been repaired as there appeared to have been some repairs made to the roof covering materials. The roof should be inspected from the surface of the roof to determine if there are missing tabs.

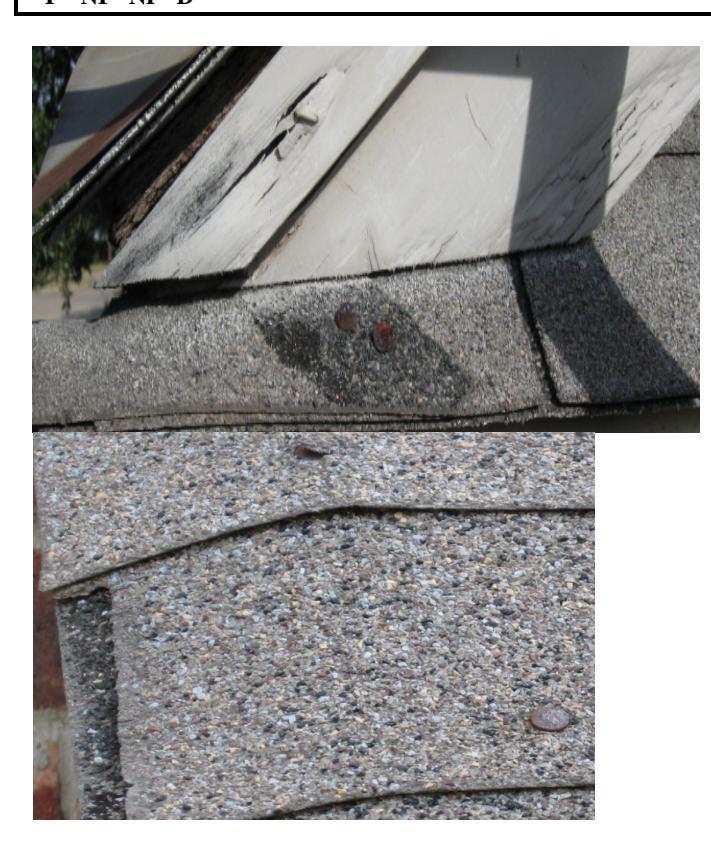
<u>Deficiency:</u> Exposed fasteners were noted in several areas of the roof's surface and some fasteners had pushed through the shingle tabs.

<u>Information</u>: The heads of the nails will rust and deteriorate, leaving openings through the roof covering material. The exposed fasteners should be covered and sealed.

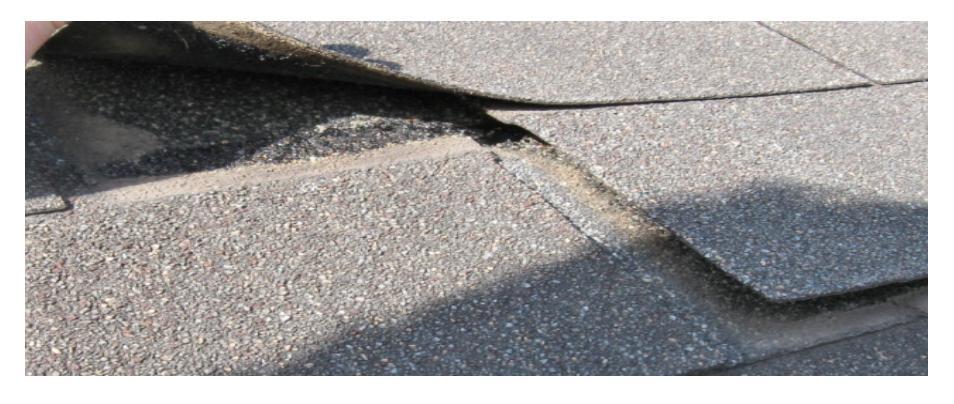
Deficiency: Some of the shingles had not bonded or sealed to each other.

shingles to the roof deck. Failure of the shingles to bond makes it far more likely that the shingles will be stripped off the roof when the roof covering material is subjected to high wind loads. Failure of the shingles to bond or seal is often an indication of a manufacturer's defect. The manufacture should be contacted for recommendations on the replacement of the shingles or for the application of an adhesive to seal the shingles.

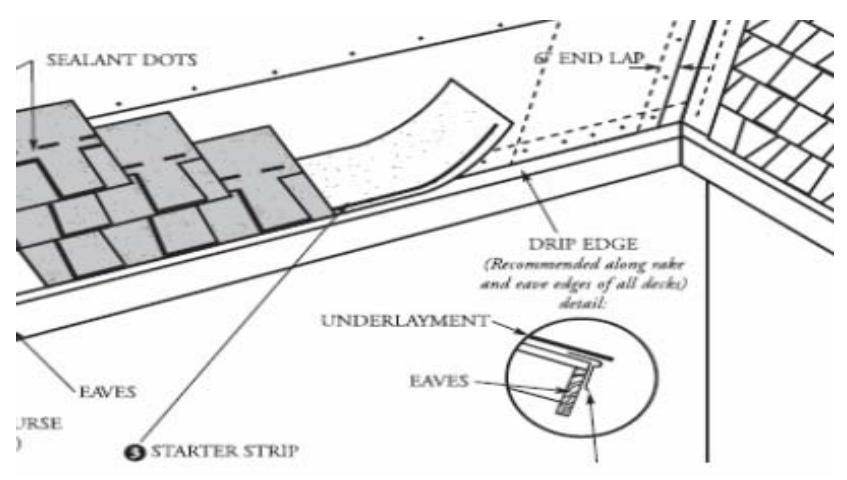
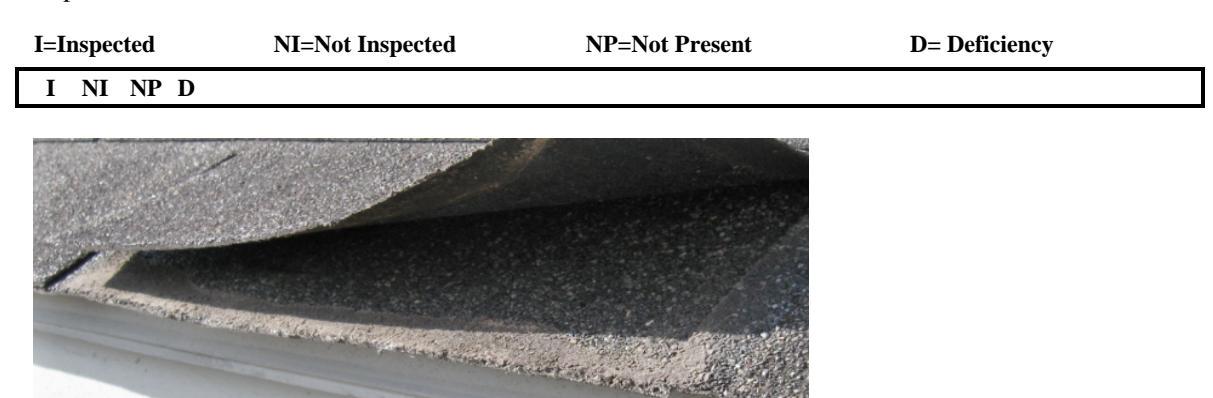
<u>Deficiency</u>: The shingles were not bonded to the started course in some areas.

<u>Information</u>: A starter course is required to be installed. Starter courses are made by using a special starter strip made by the shingle manufacturer or by removing the tags from an ordinary shingle and installing the shingle with the tab removed so that the adhesive line is at the bottom. This allows the shingle above to bond or seal to the starter strip. One of the purposes of the starter course is to provide a bonding strip for the shingle above to reduce the chances of the first shingle course being lifted in high wind conditions. The started course should be manually sealed to the shingles above or the starter course should be replaced.

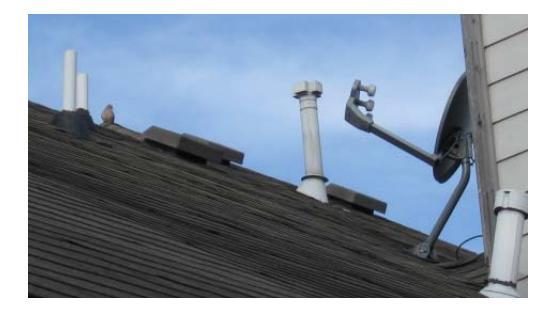
<u>Deficiency</u>: The dish for the satellite antenna system had been bolted to the roof deck through the shingles.

<u>Information</u>: There was no attempted to make the junction of the bracket with the shingles or the penetrations of the bolts through the shingles water proof. The bracket junction and the bolt penetrations should be made water proof or the dish should be removed from the surface of the roof. If the dish is removed, the damaged shingles should be replaced.

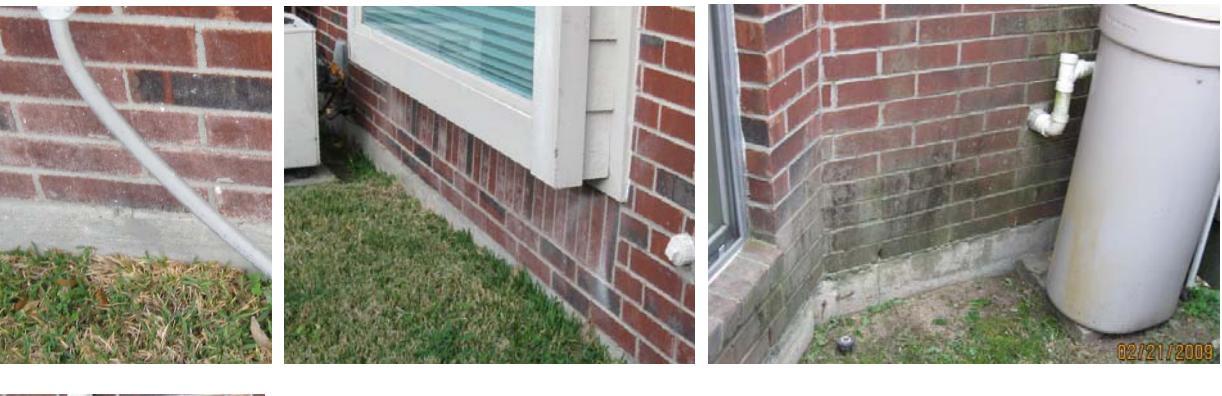
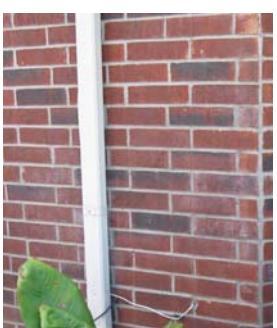
Deficiency: Efflorescence was noted on the exterior brick veneer in some areas.

<u>Information</u>: Efflorescence is the leaching of calcium salts caused by water flowing through the bricks. The leaching of the calcium salts weakens the brick over time. The sources of the water penetration should be identified and corrected. Proper wall drains should be installed. The bricks should be cleaned and sealed to prevent further water penetration problems.

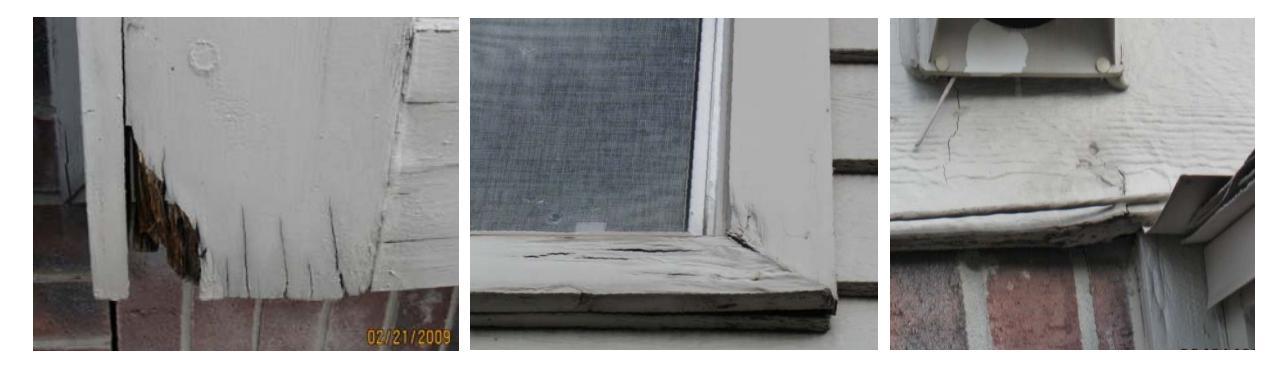
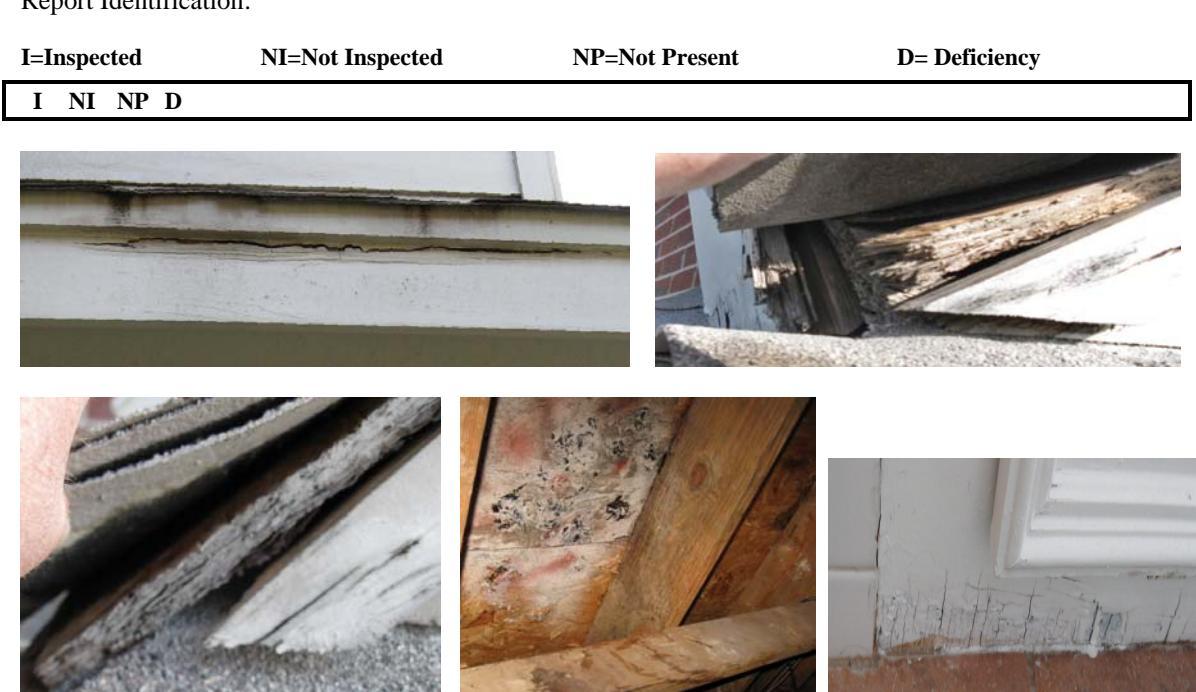
<u>Deficiency:</u> Deteriorated wood was found on the interior of the house on the master bathtub enclosure, on the exterior siding, trim, window frames, door frames, fascia and rood decking materials, etc.

<u>Information</u>: The presence of deteriorated wood indicates the need for an examination by a qualified licensed pest control inspector. Presence or damage from termites, rot or other wood infesting organisms is not part of this report. Detection of wood infesting organisms is reserved by Texas Law to the structural termite inspection. All deteriorated material, regardless of the cause, should be removed and replaced with sound new lumber finished to match the existing structure.

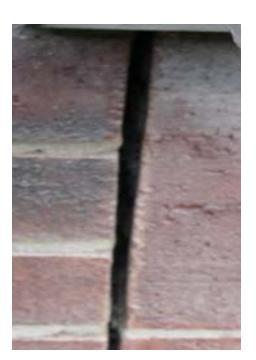
Deficiency: A control joint in the brick veneer had not been sealed with a caulk.

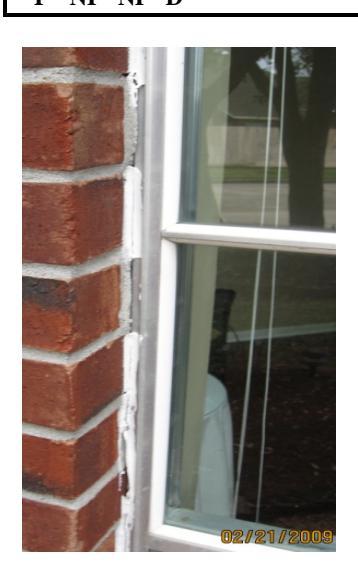
<u>Deficiency:</u> The junctions of the window frames and door frames with the brick veneer were not properly caulked.

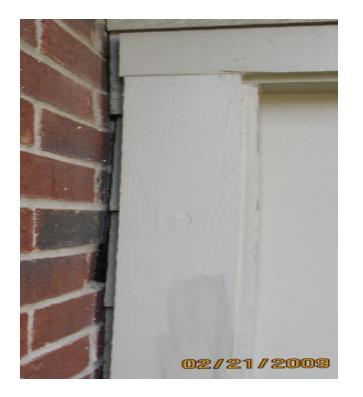
<u>Deficiency</u>: The vertical junction of the brick veneer with the wood fiber products siding was not sealed.

<u>Information</u>: The vertical junction should be sealed to prevent water penetration and to reduce access openings to pests and insects.

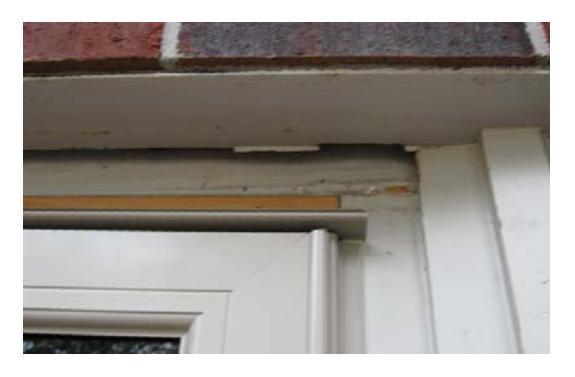
Deficiency: A piece of trim was missing from above the front door.

<u>Information</u>: The piece of trim was used to seal the opening between the front door frame and the brick veneer. The missing section of trim should be replaced.

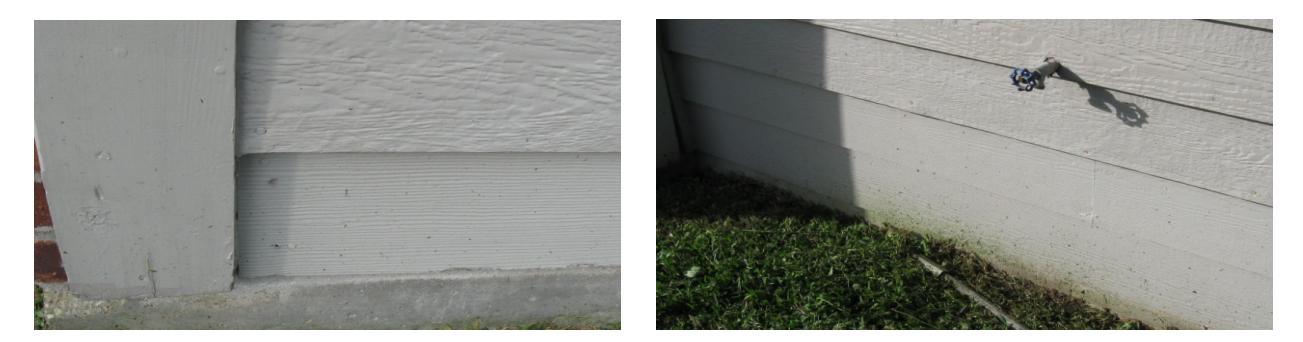
<u>Deficiency:</u> Much of the exterior "wood" siding was made of a particle board generally marketed under the name of "masonite".

<u>Information</u>: Masonite siding deteriorates much like an old sponge. As the material deteriorates, the layers of the laminated materials separate and fall of the house. Masonite siding has been the subject of any number of lawsuits and funds from these lawsuits had been set aside for the replacement of the siding. It is not known if any of these funds are still available. You should determine if there are funds from these lawsuits available for the replacement of the siding. The siding showed minor evidence of delamination and decay at the time of the inspection however, the rate of deterioration of the siding, once deterioration begins, is usually rapid. Plans should be made to replace the defective siding. Some sections of Masonite siding had already been replaced.

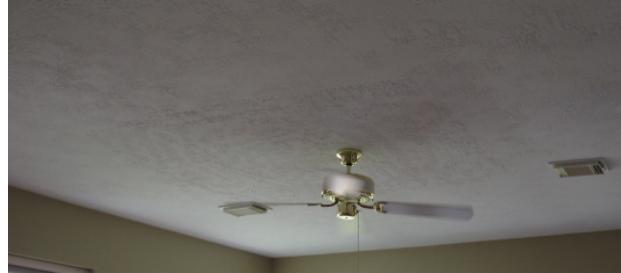
Master closet ceiling

<u>Information</u>: The causes of the patches could not be determined. Information on the patches should be obtained from the current owner.

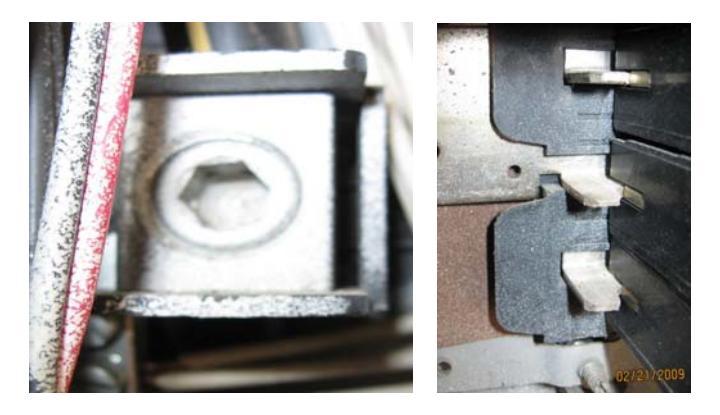
Deficiency: The conductors and components on the interior of the panel had been painted.
