PROPERTY INSPECTION REPORT

By: Fred Willcox TREC License No. 160 2008

STRUCTURAL INSPECTION

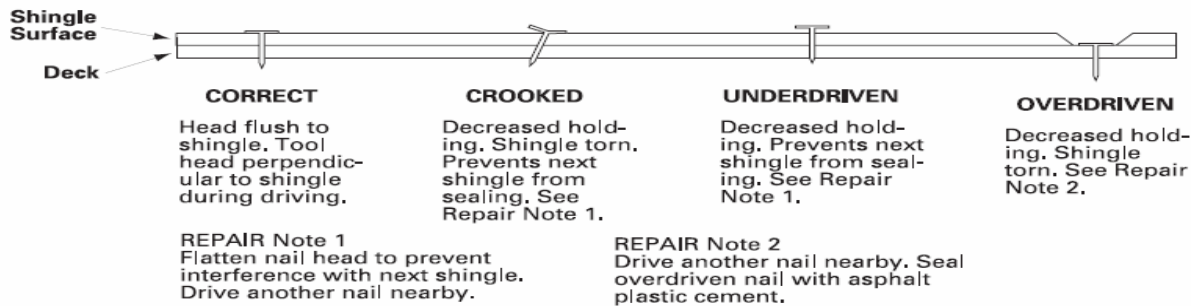
Some of the roofing shingles were improperly fastened to the roof deck. All shingles are required to have a minimum of four fasteners per shingle, six fasteners in high wind zones. The fasteners are required to be located in the nailing strip so that the fastener penetrates the shingle in approximately the middle of the shingle and penetrates the underlying shingle along the top of that shingle. Fasteners are required to be located close to the rakes and ends of each shingle to reduce the chances of the shingle from being stripped in high winds. All shingles should be properly and correctly fastened to the roof deck to prevent the shingles from being stripped from the roof in high wind conditions.

A minimum of four fasteners must be driven into the DOUBLE THICKNESS (laminated) area of the shingle. CAUTION: Do not use fastener line for shingle alignment.

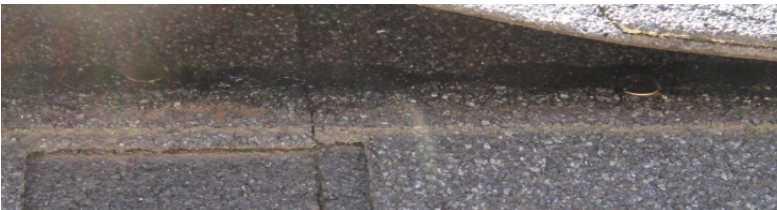
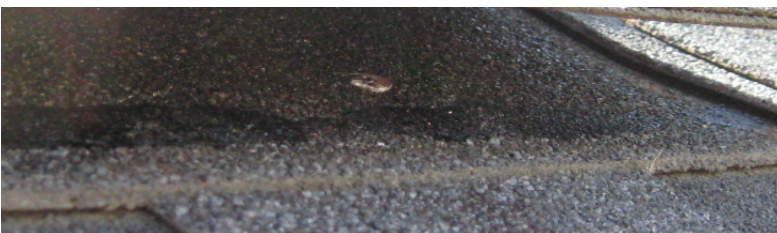
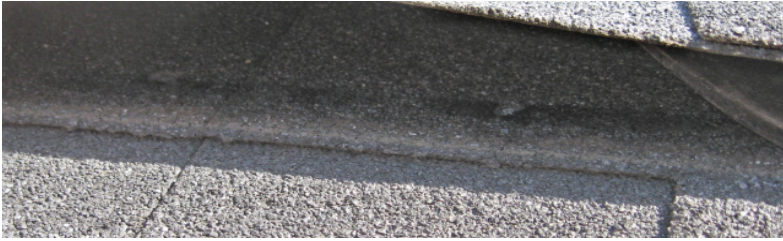
Exposed fasteners were noted in several areas of the roof's surface. The heads of the nails will rust and deteriorate, leaving openings through the roof covering material. The exposed fasteners should be covered and sealed.

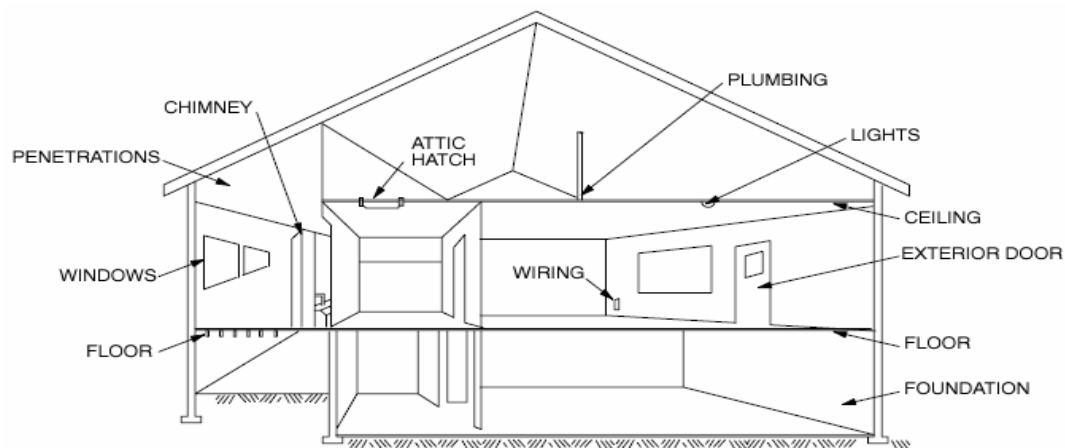
Figure N1102.1.10
TYPICAL SOURCES OF AIR LEAKAGE IN THE HOME

The inspection of the wall corners, framing penetrations, attic access ladder and door frames in the accessible attic areas revealed that all of the junctions and penetrations were not sealed in accordance with the International Energy Code, Section 502.1.4.2 and Section N1102.1.10 of the International Residential Code, as required by the State of Texas. It is important that all areas, including those that are not visible or accessible, be properly sealed as your air conditioning system has been designed with the idea that the house has been properly sealed. If the house is not properly insulated and sealed, your air conditioning system may not function properly.
