■ □ □ ■ **E. Walls (Interior and Exterior)**

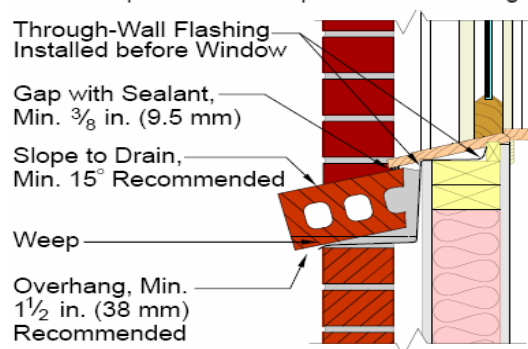
Figure 11

Window Sill in Brick Veneer/Frame Wall

The brick window ledgers were improperly or inadequately sloped at most of the window penetrations (see figure 11 above). Proper industry installation requirements are that the ledgers slope a minimum of 15 degrees away from the house to allow the ledgers to drain completely. Some of the ledgers installed on the house actually sloped toward the house which will force water into the wall cavities. The ledgers should be removed and adequately sloped, at a minimum, new ledgers should be installed.

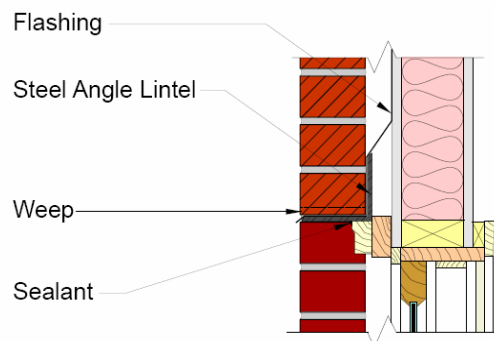
Figure 14

Window Head in Brick Veneer/Frame Wall

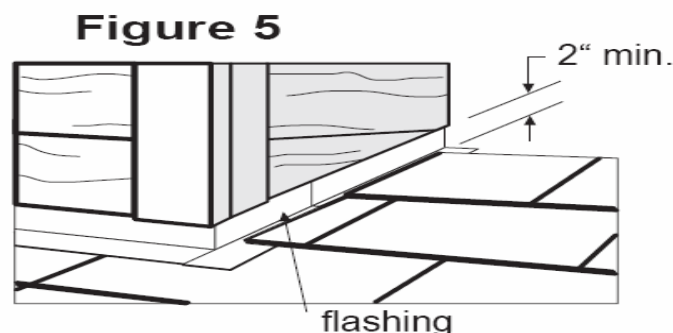
At the juncture of the roof and vertical surfaces, flashing and counterflashing shall be provided per the roofing manufacturer's Instructions.

Provide a 2" clearance between the roofing and the bottom edge of the siding and trim.

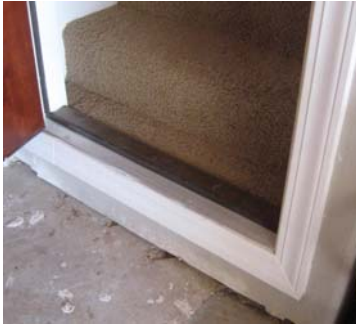
The stair risers were not uniform in size and the height of the first riser from the garage exceeded the maximum allowable riser height. This condition creates a hazard to the user of the stairs. The brain adjusts your stride to the height and depth of stairs and one step that is a different size can cause you or another user of the staircase to trip and fall. The risers should be made uniform in height for safety.

To obtain the best uniformity possible in a flight of stairs, the maximum variation between the highest and lowest risers is limited to 3/8 inch (9.5 mm). This tolerance is not to be used as a design variation, but its inclusion is in recognition that construction practices make it difficult to get exactly identical riser heights and tread dimensions in constructing a stairway in the field. Therefore, the code allows the variation indicated in Commentary Figure 311.5.3.1(2).
