PROPERTY INSPECTION REPORT

By:	Fred Willcox	TREC License No. 160	August , 2007	
	File No. 20068	713-461-0009

STRUCTURAL INSPECTION

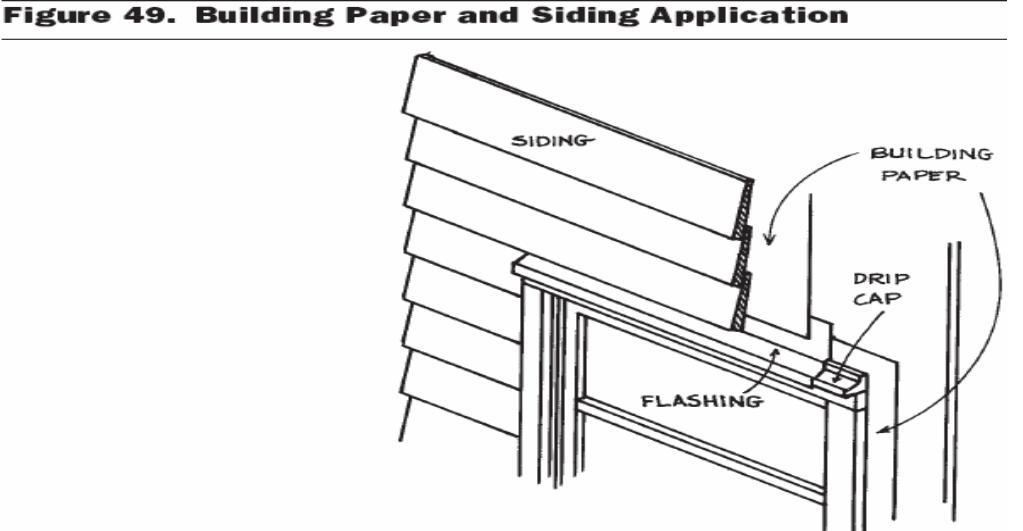
The code requires that all points subject to the entry of moisture be appropriately flashed. Roof and wall intersections and parapets create significant challenges, as do exterior wall openings exposed to the weather. Where wind-driven rain is expected, the concerns are even greater. While the code identifies a number of locations where flashing is specifically required, the entire exterior envelope must be weather-tight to protect the interior from weather. Therefore, any location on the exterior envelope that provides a route for the admission of water or moisture into the building must be properly protected.

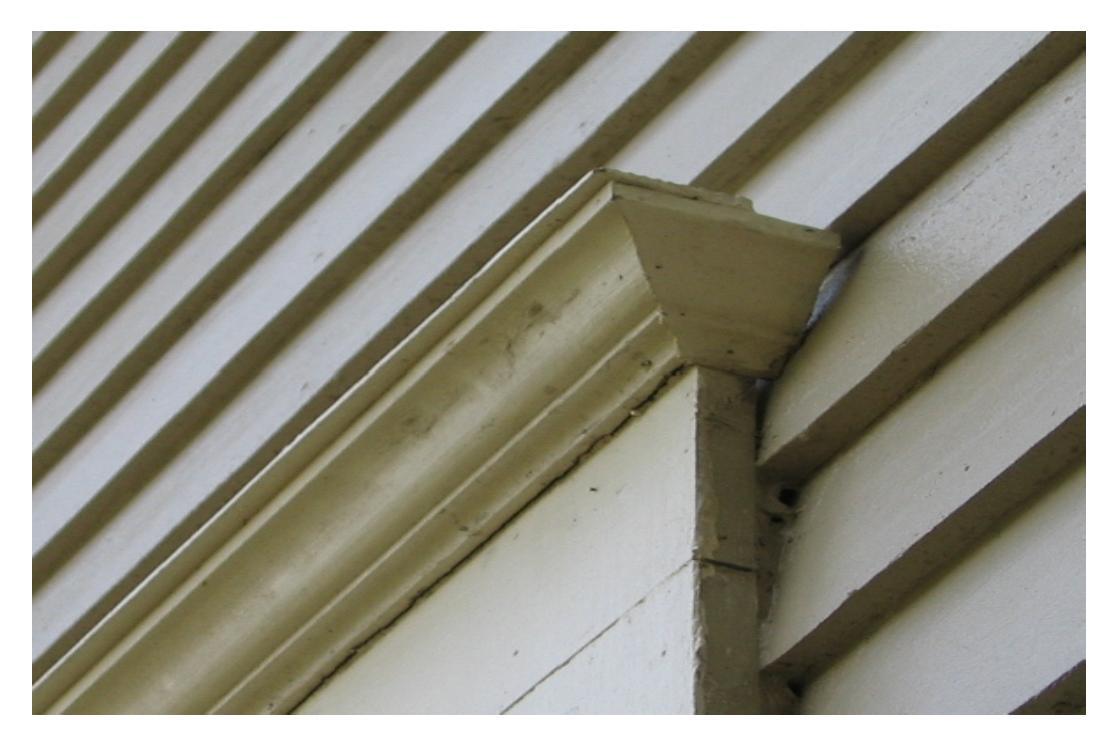
The junctions of the siding with the wind and door frames were not sealed. These openings allow moisture into the wall framing behind the siding. These junctions should be sealed with a quality, water proofing adhesive to prevent further water penetration.
