# **PROPERTY INSPECTION REPORT**

Concerning:		Missouri City, Texas		
By: Fred Willcox		TREC License No. 160		
	File No.	713-461-0009

The inspection was of a two story, single frame dwelling under construction. The house was in the framing stage at the time of the inspection.

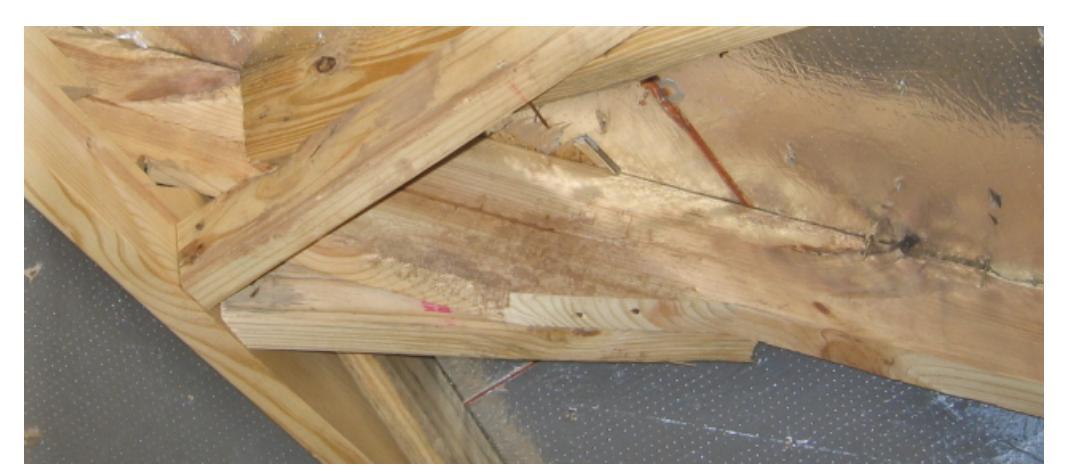
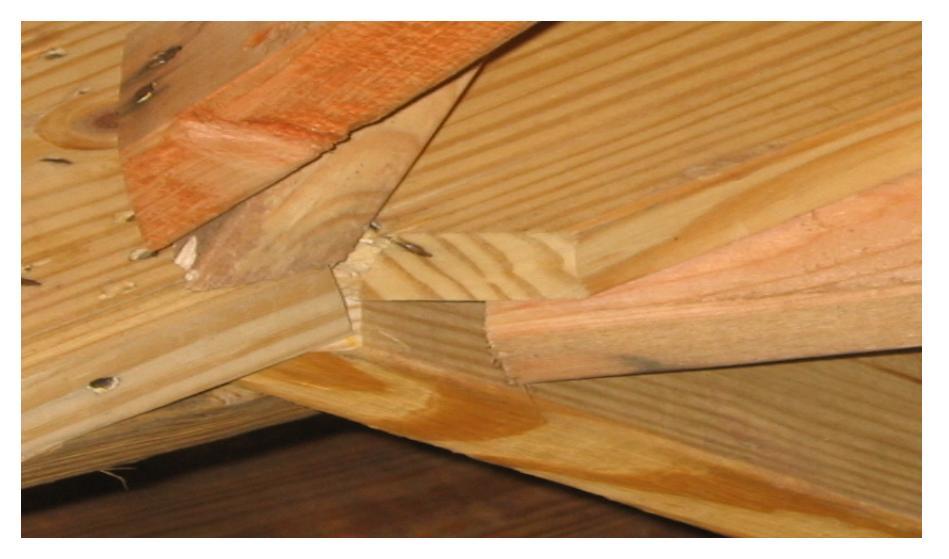
A brace on a valley was installed less than 45 degrees from the horizontal. This installation merely allows the strut or brace to rotate down when loaded by the roof. The strut or brace should be removed and replaced with a brace installed at the proper angle, which ideally should be perpendicular to the valley rafter.
