PROPERTY INSPECTION REPORT

(Name of Cl	lient)		
Concerning:				Houston, T	exas
		(Address or Other Identification	n of Inspected	Property)	
By:	Fred Willcox	Professional Inspecto	or #160	February, 2009	
	(Name and I	License Number of Inspector)			(Date
	File No	713 461 0000 m	www.will	ovingnostions our	n

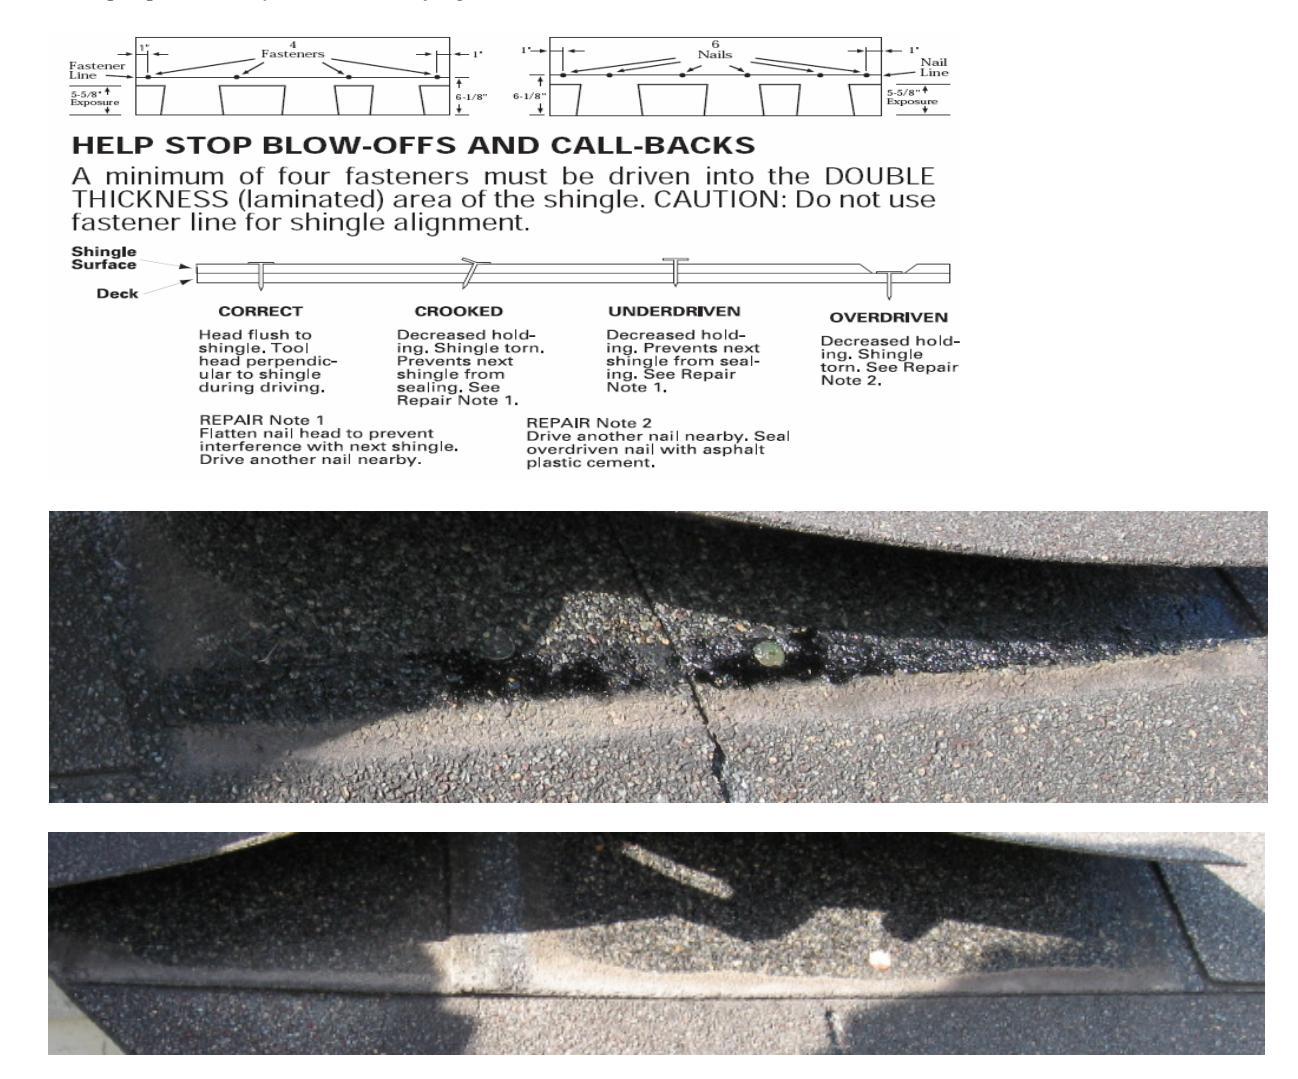
Example provided by GAF/Elk Roofing Materials Installation Instructions.

In all cases, the minimum number of fasteners for asphalt shingles must be the number required by the shingle manufacturer. It is typical for asphalt strip shingles to be attached to the roof sheathing by at least four fasteners for each strip shingle. If individual shingles are installed, at least two fasteners are required per shingle. For very steep roof slopes, the manufacturer's installation instructions should be reviewed for any special fastening methods. Where the basic wind speeds in accordance with Figure R301.2 (4) are greater than or equal to 110 mph (177.1 km/h), special testing is required to determine how such roofing should be fastened. The fastening methods must be specifically tested to ASTM D 3161, but the test must be modified to accommodate the wind speed of 110 mph (177.1 km/h). ASTM D 3161 deals with several ranges of wind speeds. More basic wind speeds are considered up to 110 mph (177.1 km/h). Therefore, areas prone to higher winds must comply with the modified test. From the Commentary to the IRC.

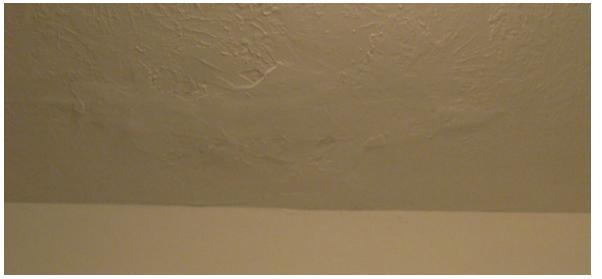
<u>Deficiency:</u> There were patches in the drywall coverings of the ceilings in the living room, master closet and upstairs hallway, etc.

<u>Information</u>: The causes of the patches could not be determined. Information on the patches should be obtained from the current owner.

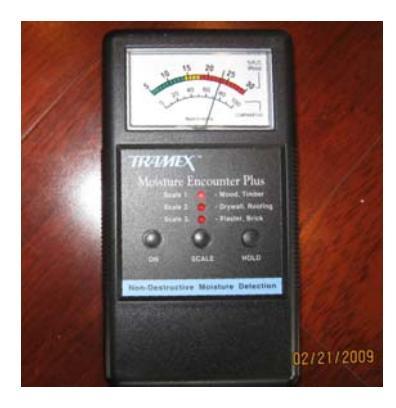
<u>Deficiency:</u> High moisture contents were found in the hardwood flooring slats by the use of a non destructive water meter throughout the first story of the house where hardwoods were installed.

<u>Information:</u> High moisture contents may indicate moisture penetration through the flooring system. All sources of possible moisture penetration should be determined and corrected. The moisture content of the surface of the concrete slab should have been determined prior to the installation of the hardwood flooring according to manufacturer's and the industry's installation policies. The moisture content of the surface of the slab should be determined at this time. If there is excessive moisture in the surface of the slab the floor will not stay bonded and the flooring may deteriorate. You should consult a competent hardwood flooring contractor for information on drying the hardwood flooring and keeping it dry in the future.

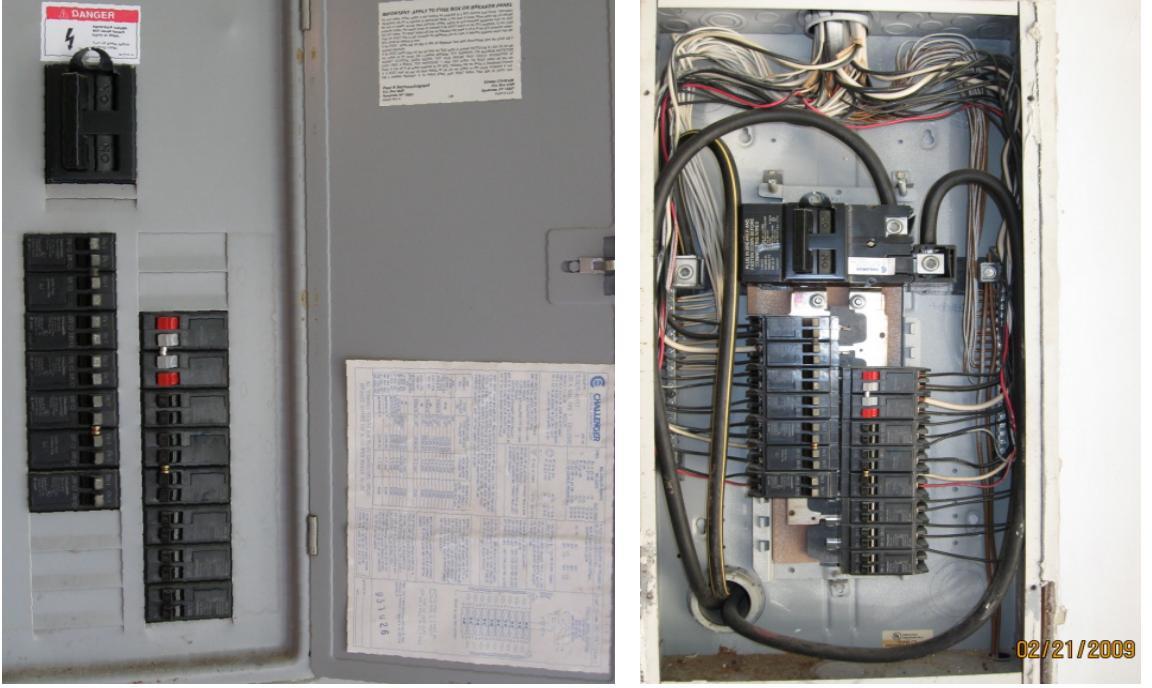
Deficiency: The circuits were not properly labeled or identified in the breaker panel.

<u>Information</u>: As the circuits were not identified, it could not be determined if the circuits were properly sized for the listed appliances. Over sizing of overcurrent protective devices on any appliance is a recognized fire hazard. The National Electric Code, Section 408.4, states that identifying circuits as 'bedrooms or wall outlets or light switches' is not adequate. Labeling must be specific as to which appliances are to be protected by the over current device. The circuits should be rated and certified by a competent electrician according to the listings of the appliances.

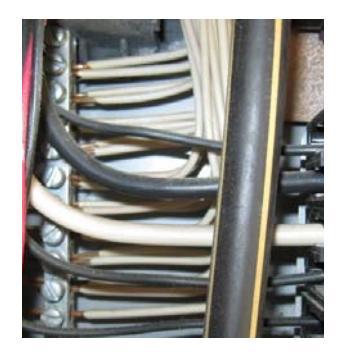
Deficiency: The conductors and components on the interior of the panel had been painted.

<u>Information</u>: Paint is an inhibitor to electrical current. The presence of paint on the conductors and components increases the resistance in the conductors and components which causes an increase in amperage flow. It is the amperage that creates heat. All electrical components and conductors are designed to dissipate certain amounts of heat. The presence of inhibitors can cause an increase in amperage to overcome the additional resistance cause an increase in heat. This unnecessary excess heat reduces the functional life of the conductors and components and the appliances, increases electrical usage and raises electrical bills and increases the chances of a fire starting. The panel and all other foreign materials or compounds should be removed from all electrical conductors and components for safety.

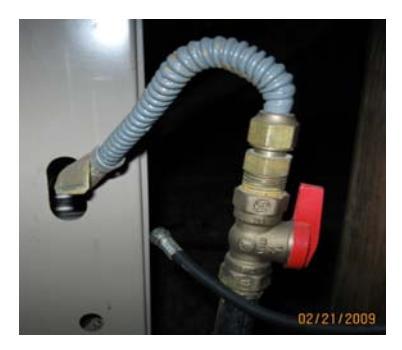
<u>Deficiency:</u> The flexible gas pipe used to connect the unit to the metal gas pipe extended through the side of the heater.

<u>Information:</u> Flex pipe should not be extended through the side of the heater as the vibration of the heater can cause a hole to be worn in the flex material. The flexible pipe should be removed from the interior of the heater and a metal pipe should be installed from the interior of the heater to the exterior of the heater housing.

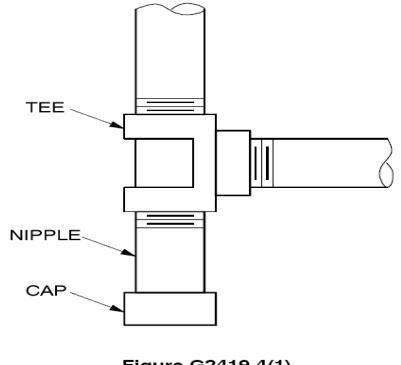
Figure G2419.4(1) SEDIMENT TRAP

Sediment traps are designed to cause the gas flow to change direction 90 degrees at the sediment collection point, thus causing the solid or liquid contaminants to drop out of the gas flow. See Commentary Figure G2419.4(1).

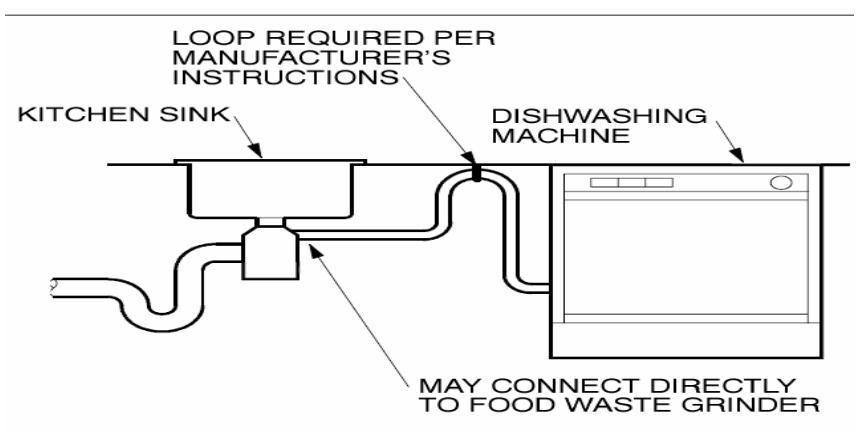
Deficiency: There was an inadequate anti siphon loop installed in the drain pipe.

<u>Information</u>: An air gap or anti siphon loop is used to prevent backflow of contaminated water and bacteria from the disposer or plumbing drain back into the dishwasher. Many models come with backflow valves, but the anti siphon loop or mechanical air gap is still required. An anti siphon loop is created by forming an upside down "U" in the drain hose. The top of the "U" should be against the underside of the counter top. The hose is the tied in place, usually to the underside of the sink or to the faucet supply pipes.
